# LIBERTY BAY TMDL IMPLEMENTATION PLAN

Prepared for:

**City of Poulsbo**  
200 NE Moe Street  
Poulsbo, WA 98370

## June 2016

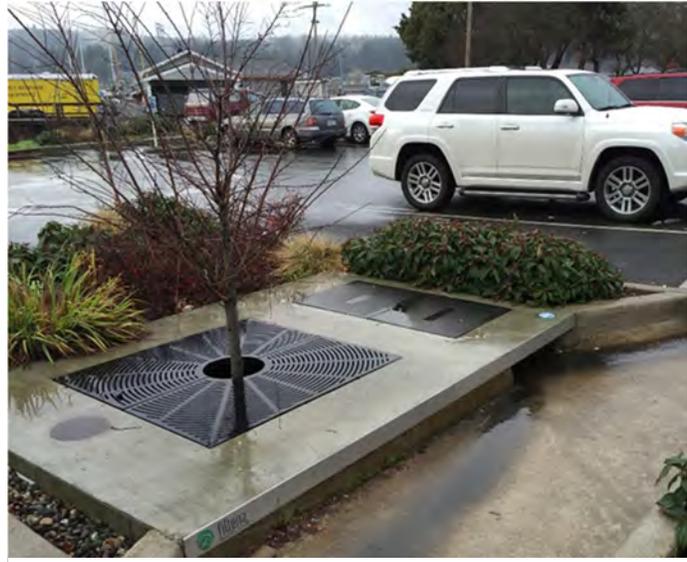
*Filterra vault used in Anderson Parkway retrofit.*

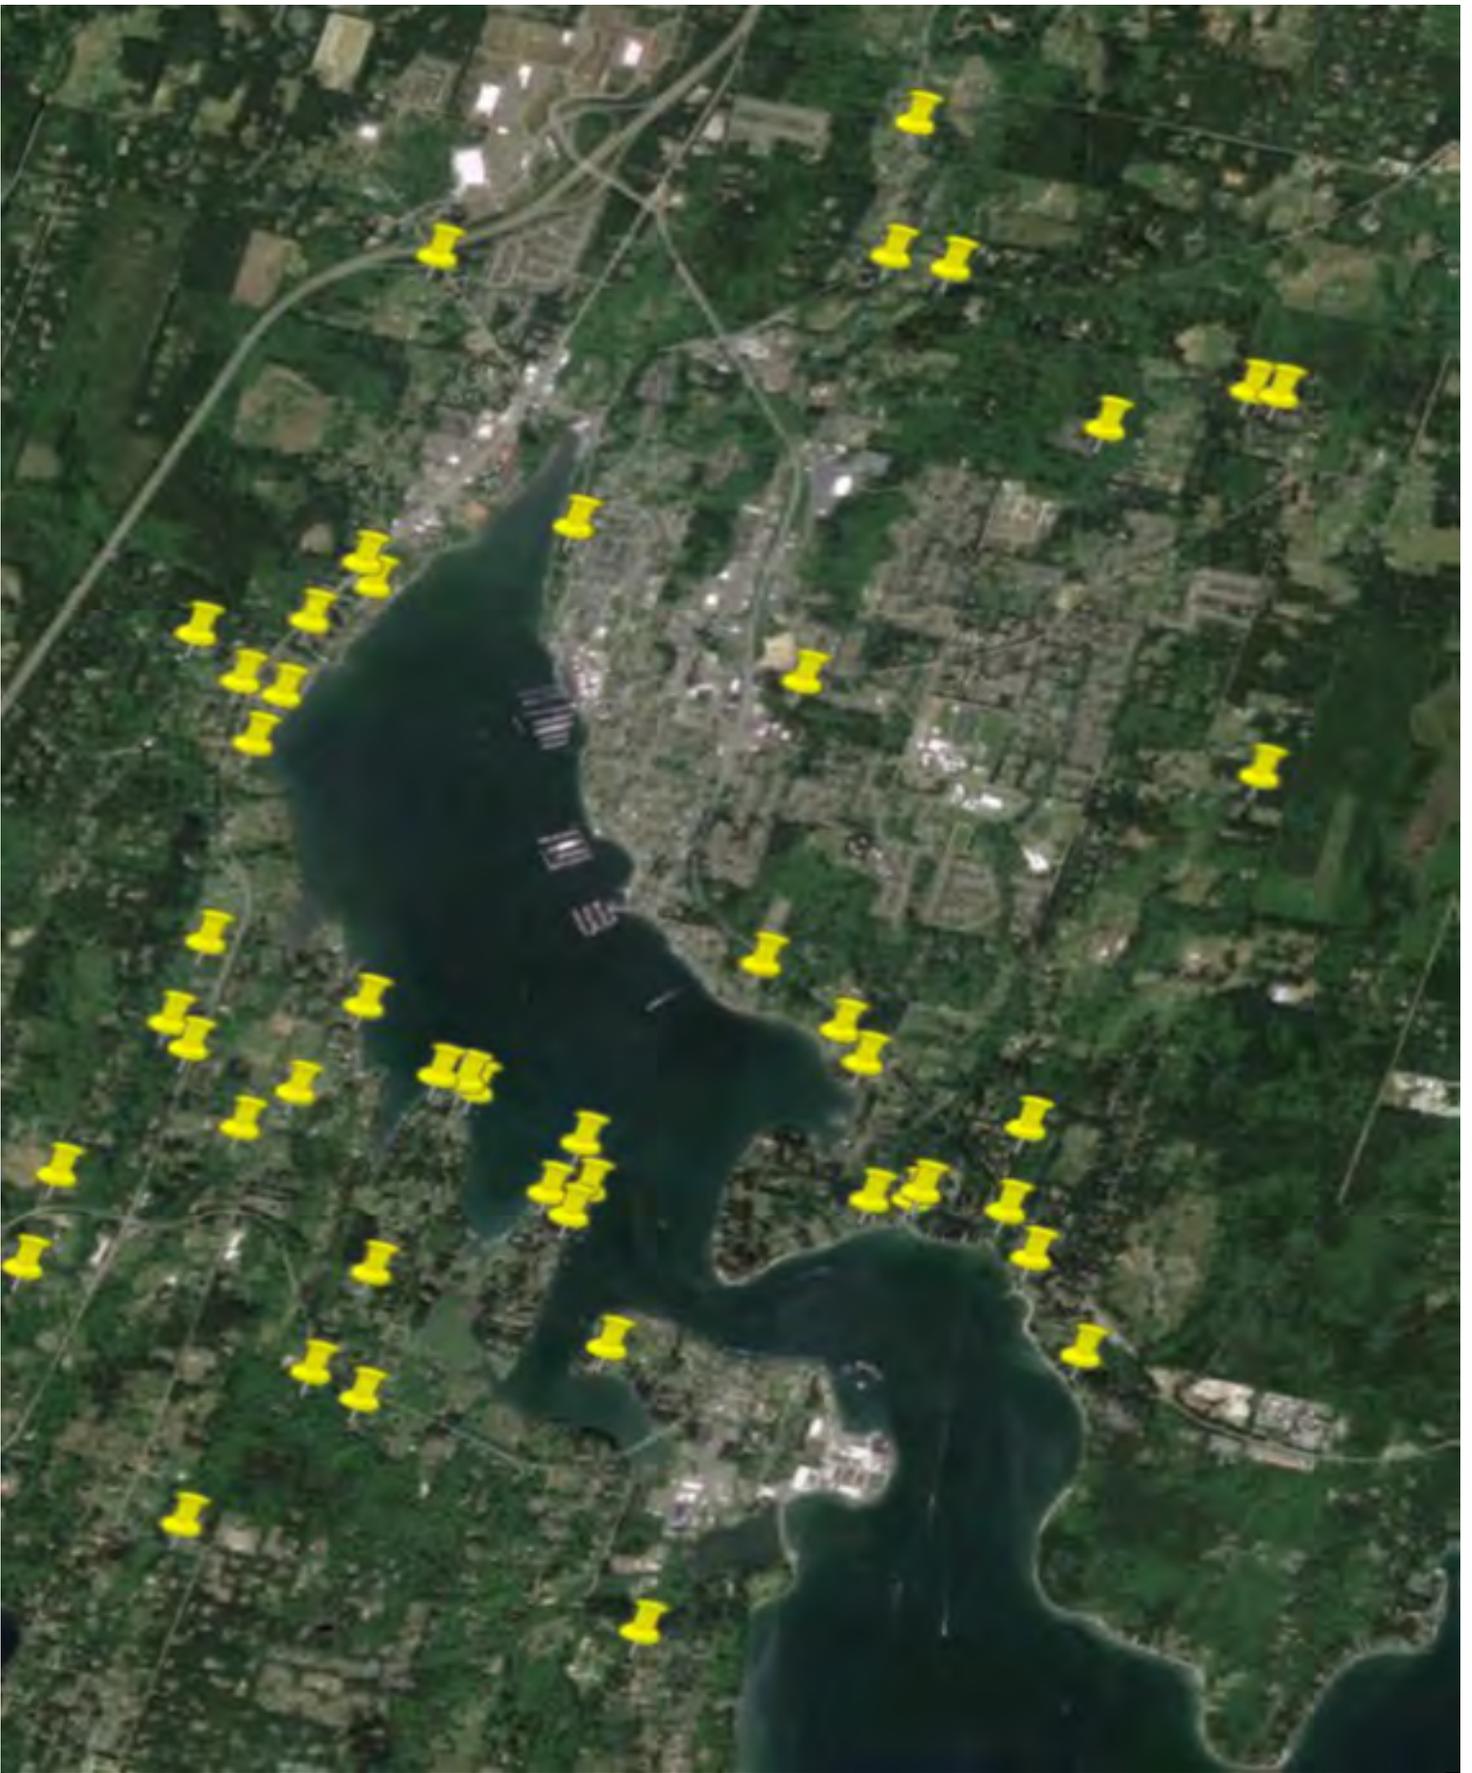
**Figure 2-11**  
**On-site Sewage System Repairs**  
TMDL Implementation Plan  
City of Poulsbo

The KPHD investigated 854 properties in the watershed as part of the 2014 Liberty Bay Watershed Restoration Pollution Identification & Correction Program Project and identified 51 failing OSS. Figure 2-11 shows the location of failing OSS and illustrates that most of the failing OSS were located within 200 feet of the shoreline (KPHD 2014b). As of April 2014, 47 of the 51 failing systems had been repaired (KPHD 2014). Within the City limits, OSS use is minimal with approximately 25 systems currently operating.

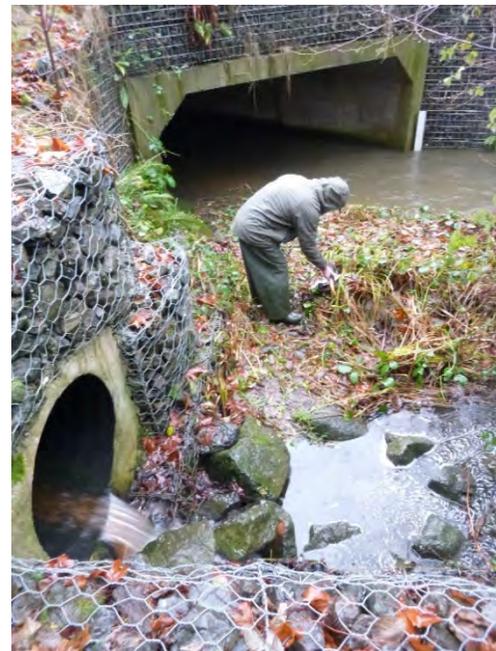
*Rain event conditions, SFDC*

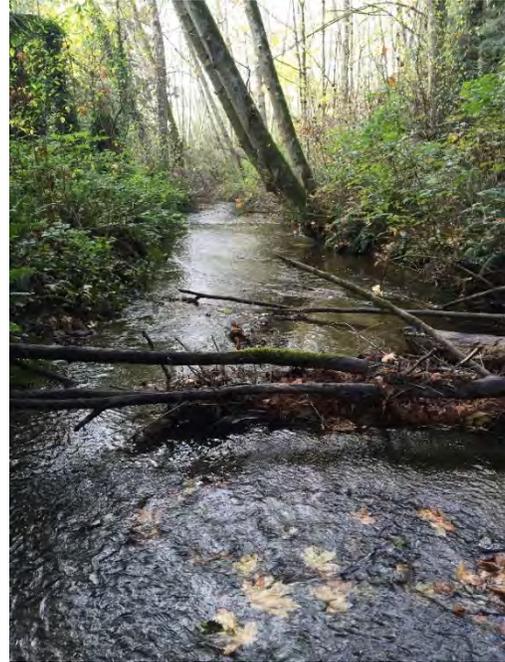
*Dogfish Creek above Fish Park.*

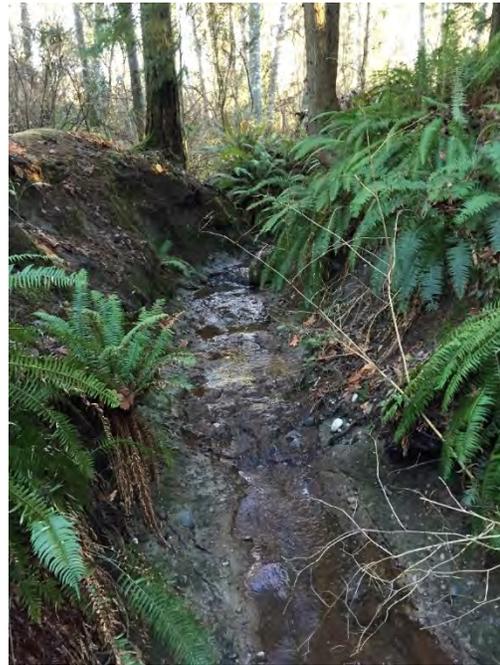
*Incised and scoured channel, Wilderness Park in upper SFDC basin.*

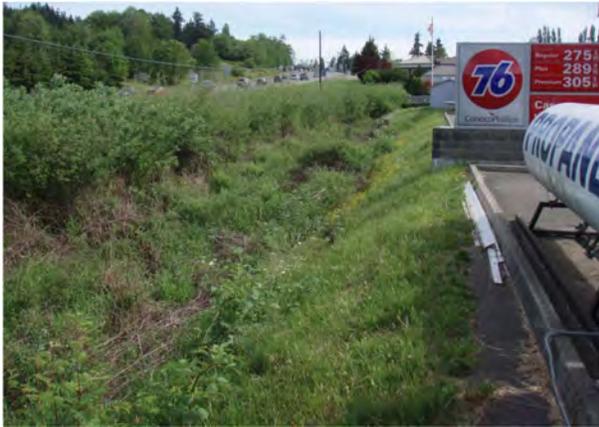
*SFDC north of Liberty Road, 2010.*

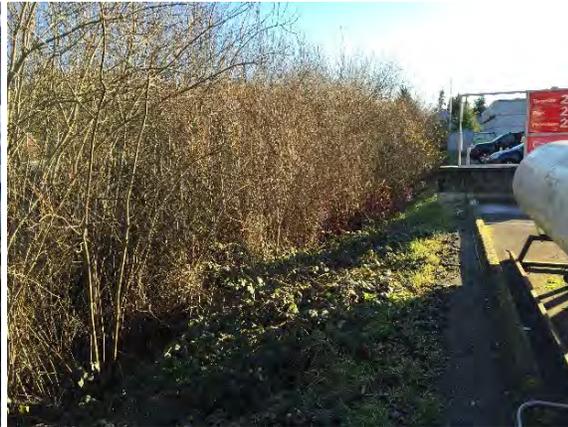
*SFDC north of Liberty Road, 2015.*

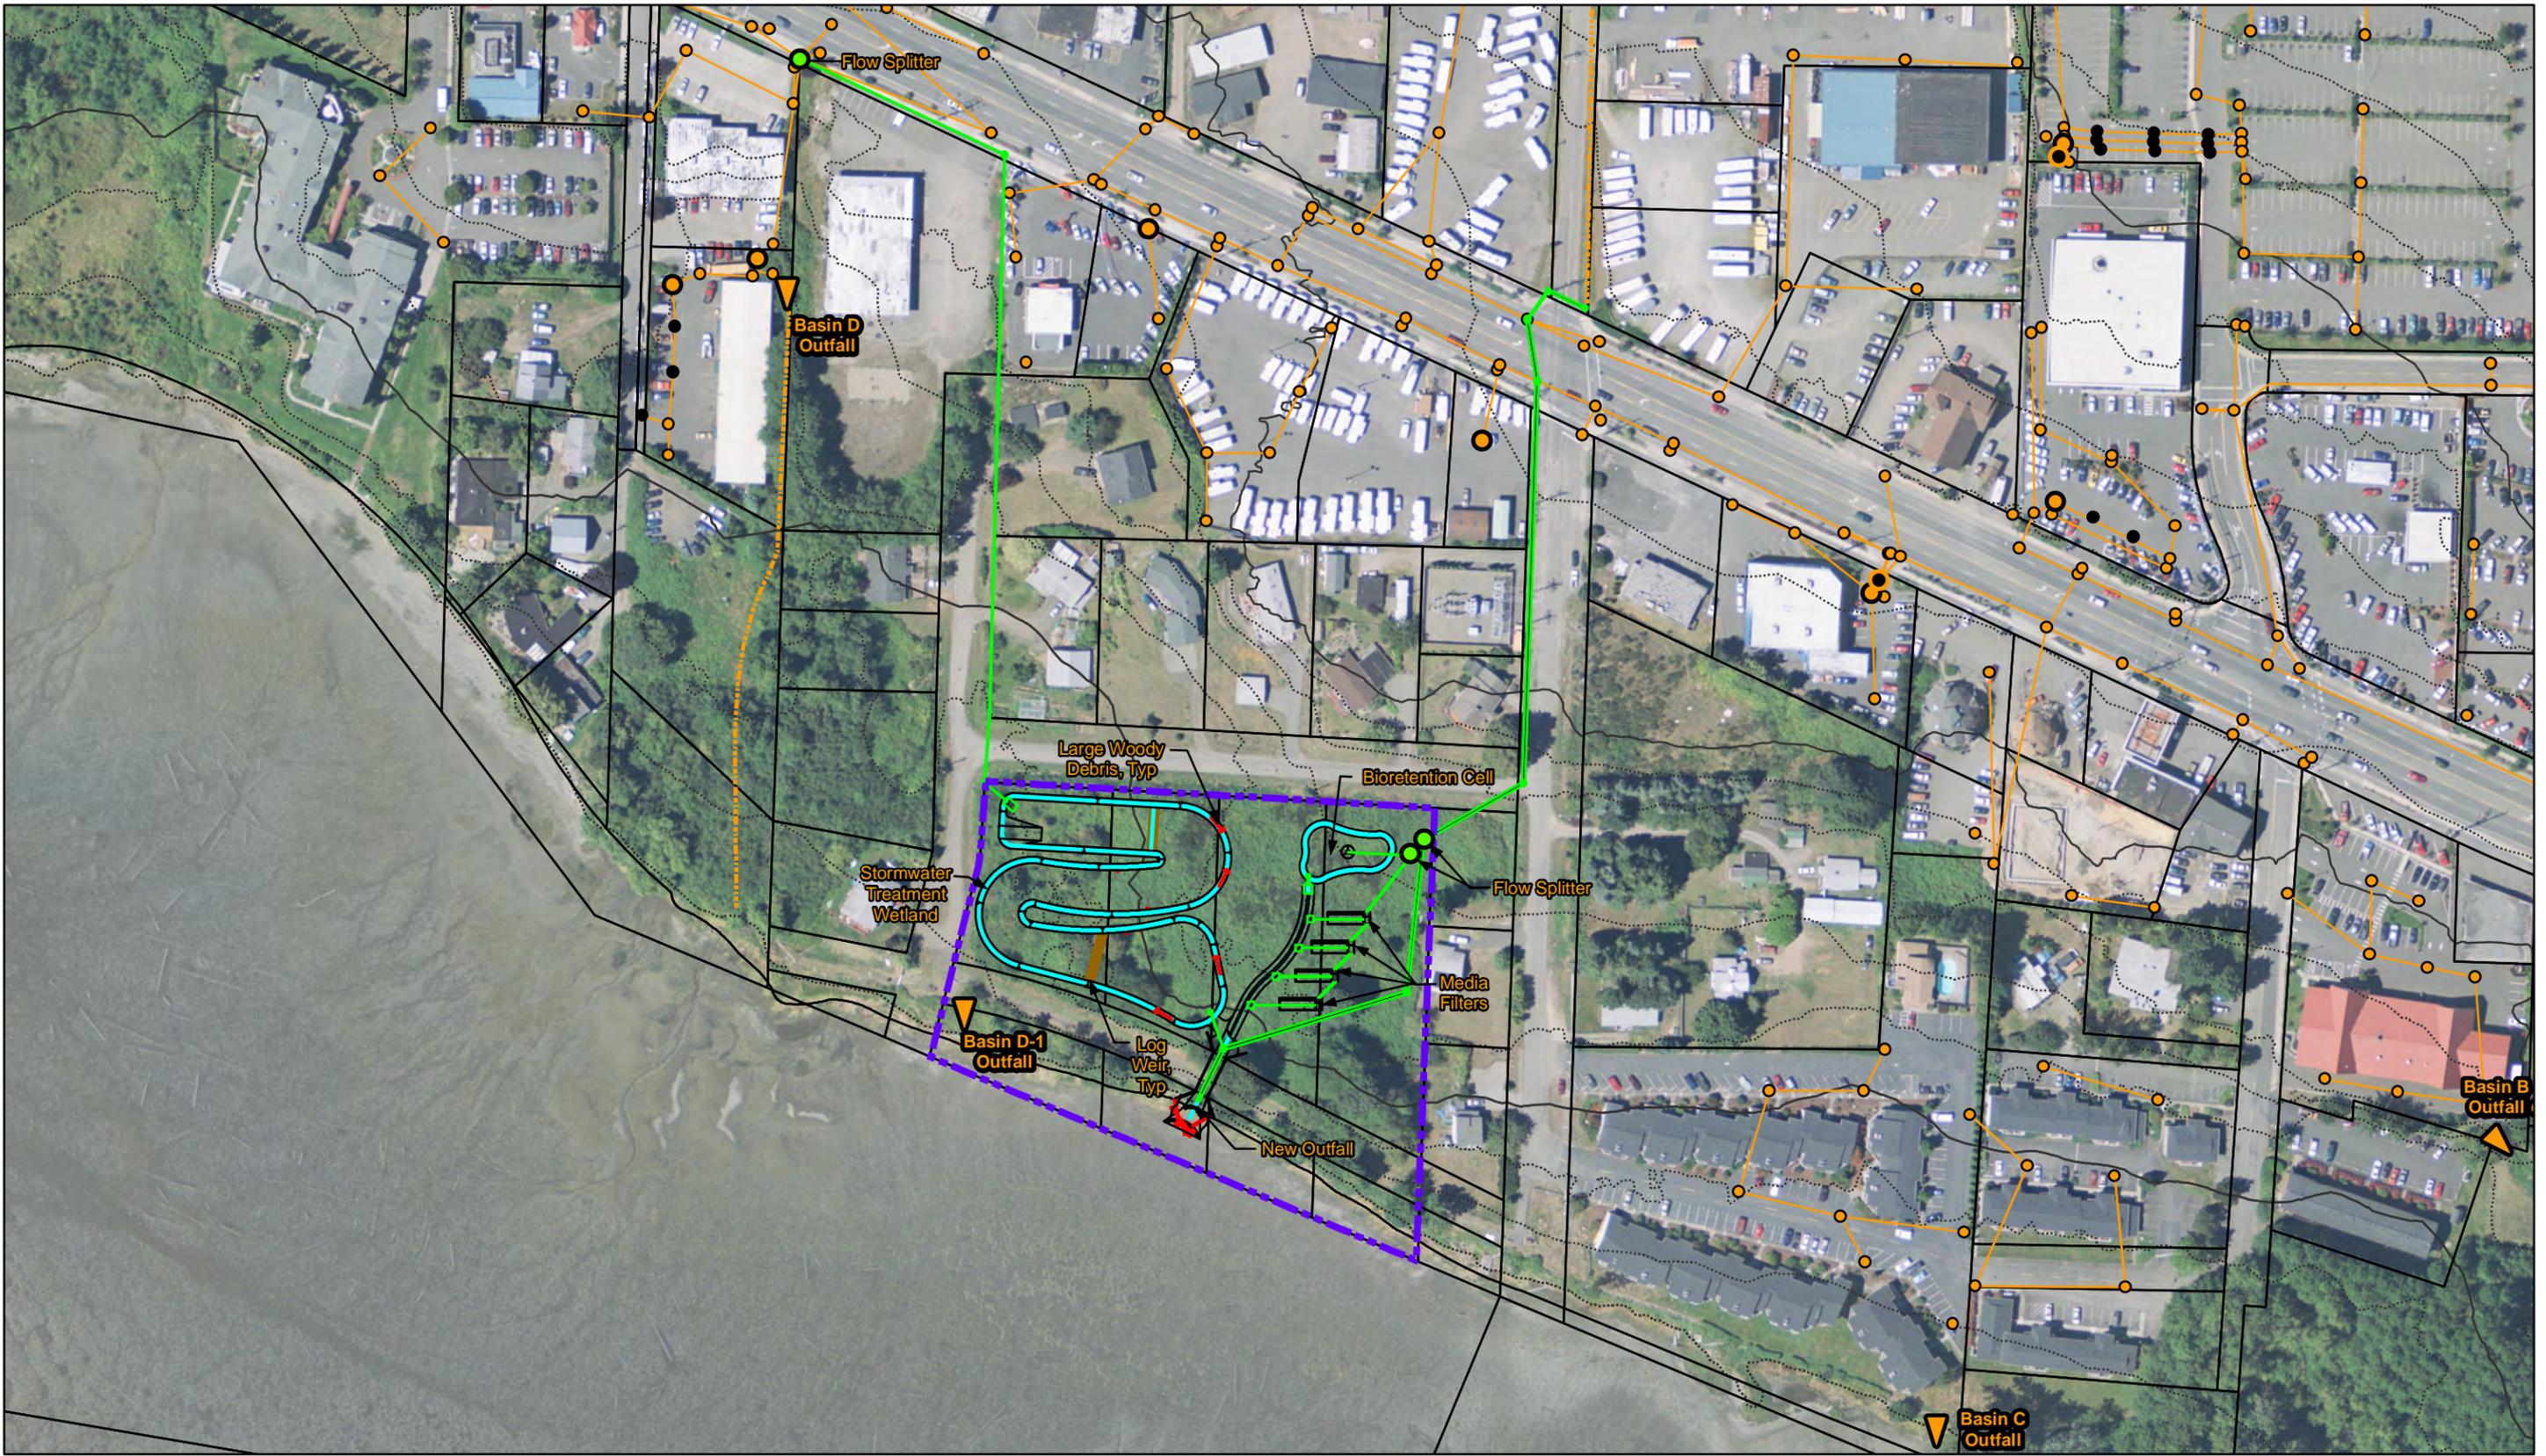
**Figure C-3.**  
**Poulsbo Creek Outfall Rehabilitation**  
 TMDL Implementation Plan  
 City of Poulsbo

| ..... 5' Contours | —— Parcel Line | ● Catch Basin | ● O/W Separator | —— Proposed Stormwater Pipe |

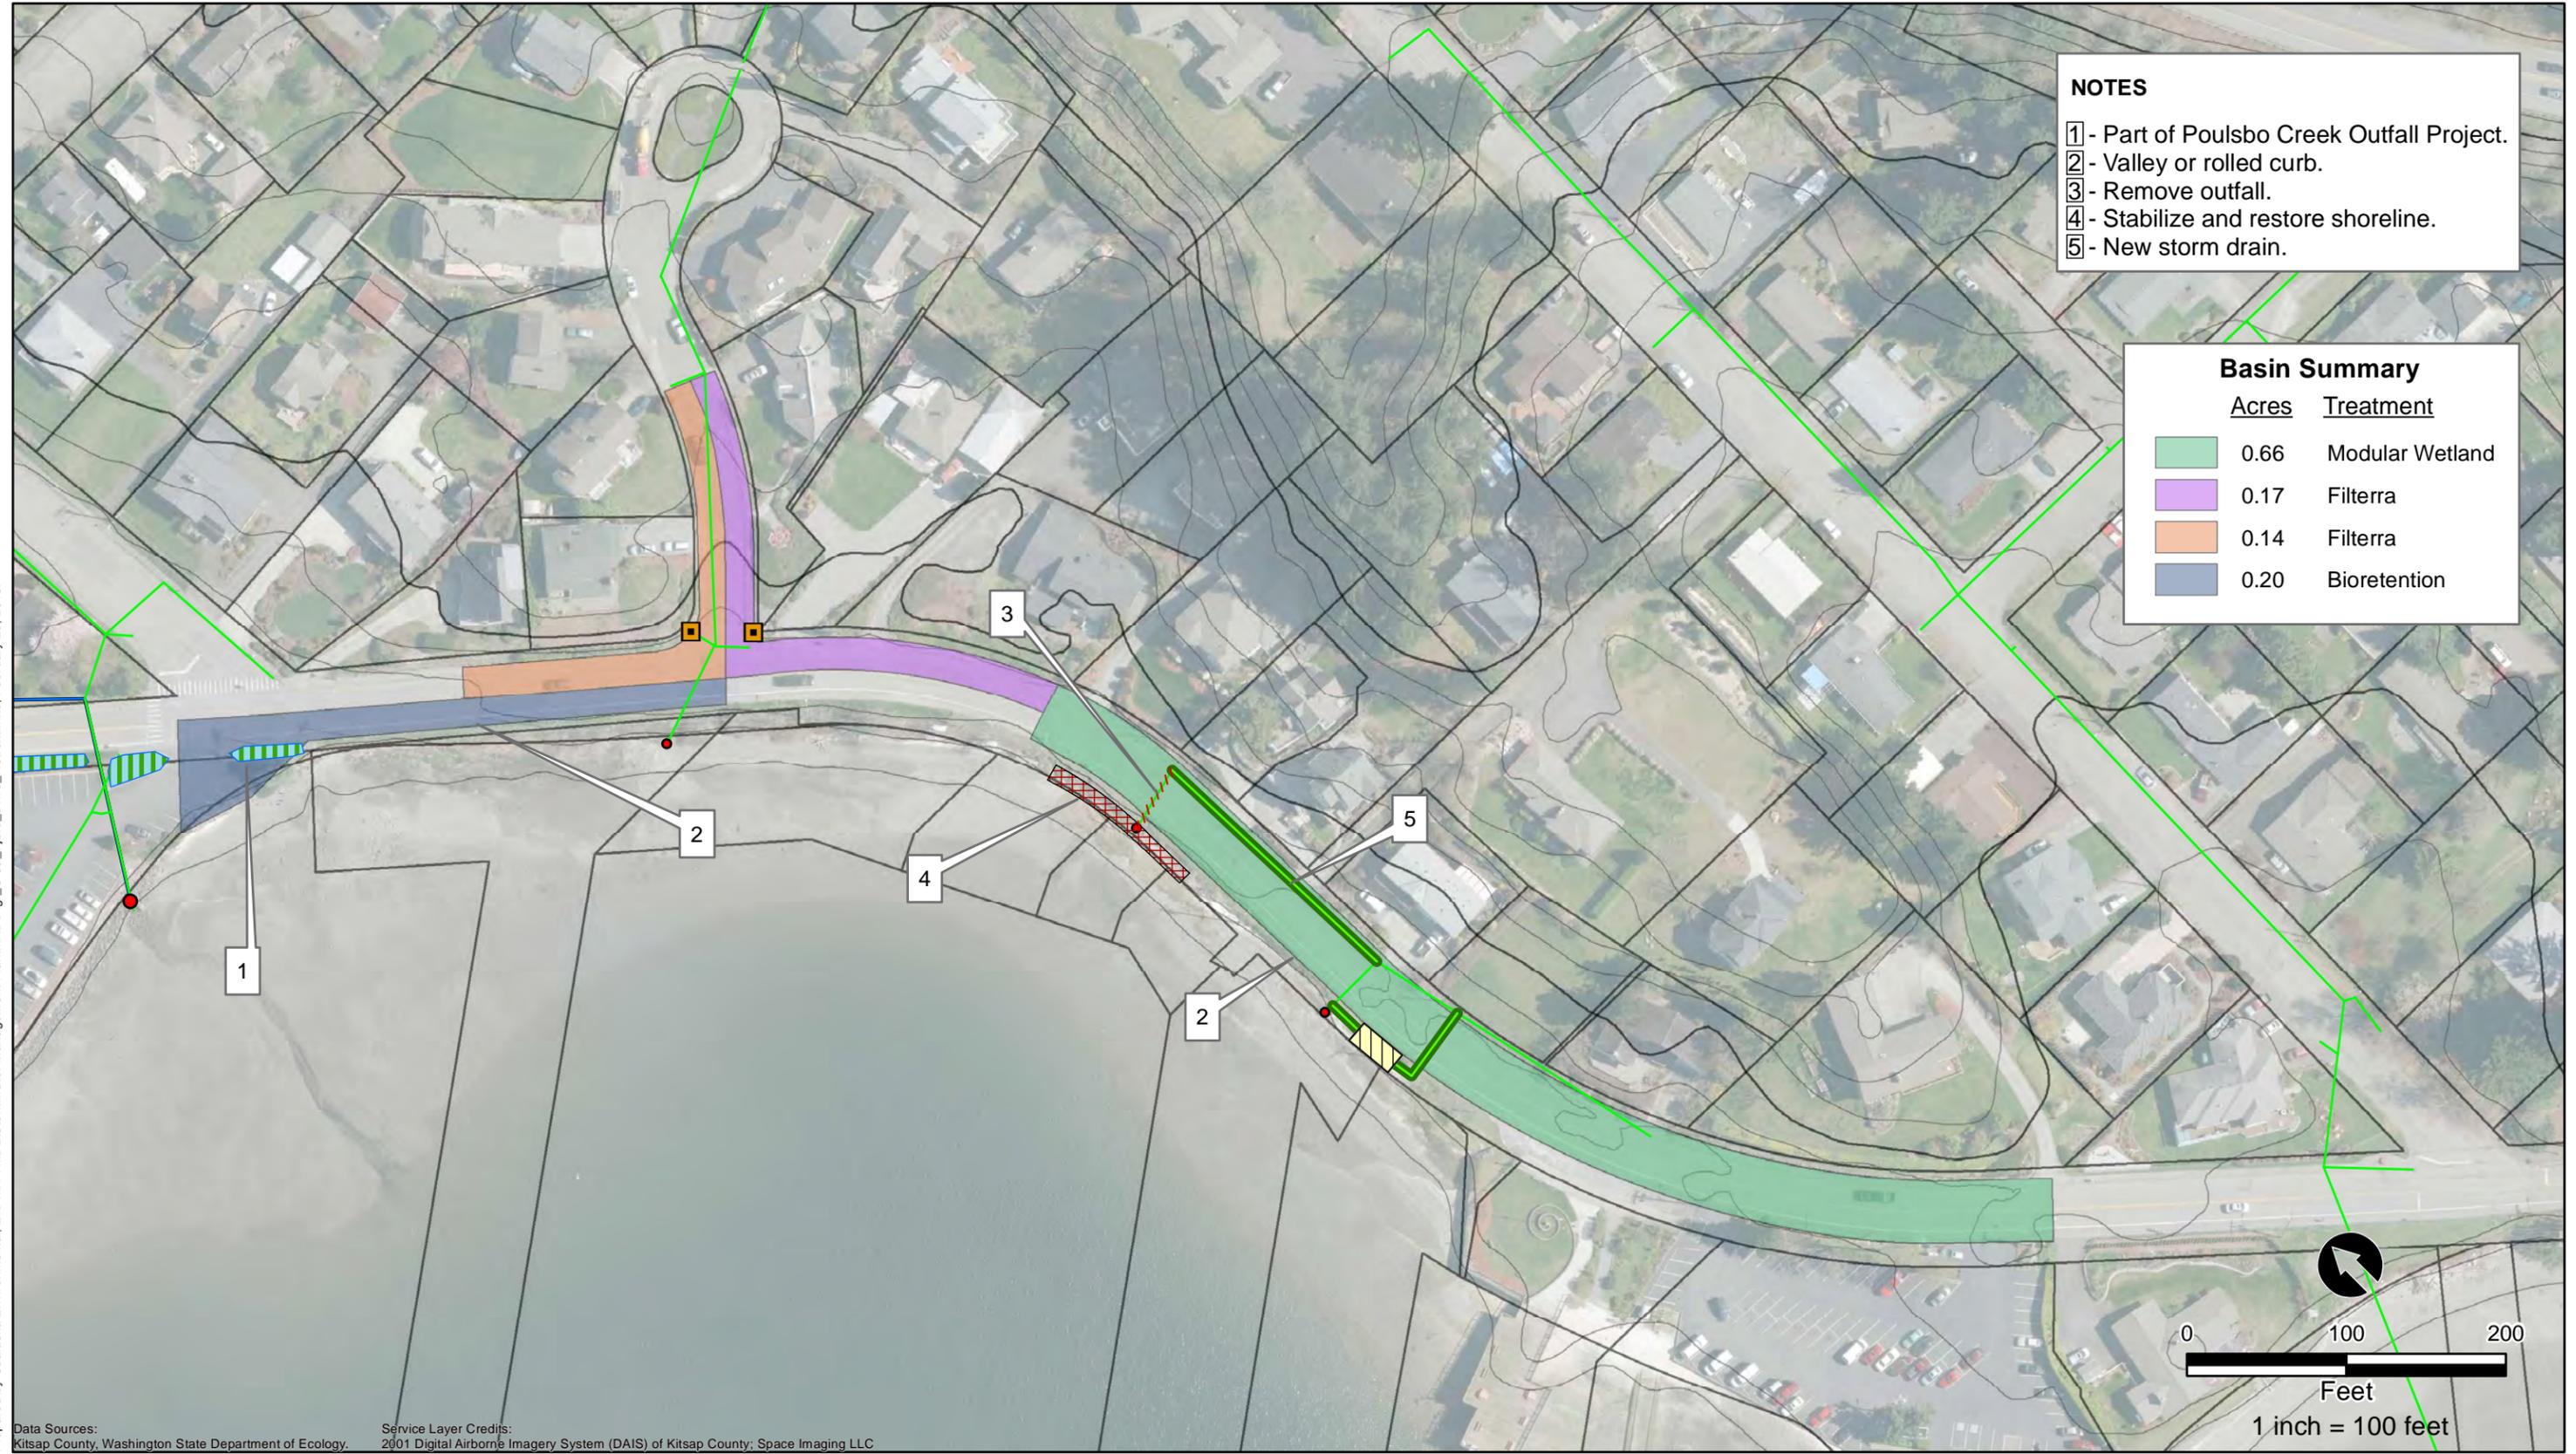
**Project C-5.**  
**Ridgewood/Kevos Pond Basin**  
**Drainage Improvements**  
 TMDL Implementation Plan  
 City of Poulsbo

- 1 - Part of Poulsbo Creek Outfall Project.
- 2 - Valley or rolled curb.
- 3 - Remove outfall.
- 4 - Stabilize and restore shoreline.
- 5 - New storm drain.

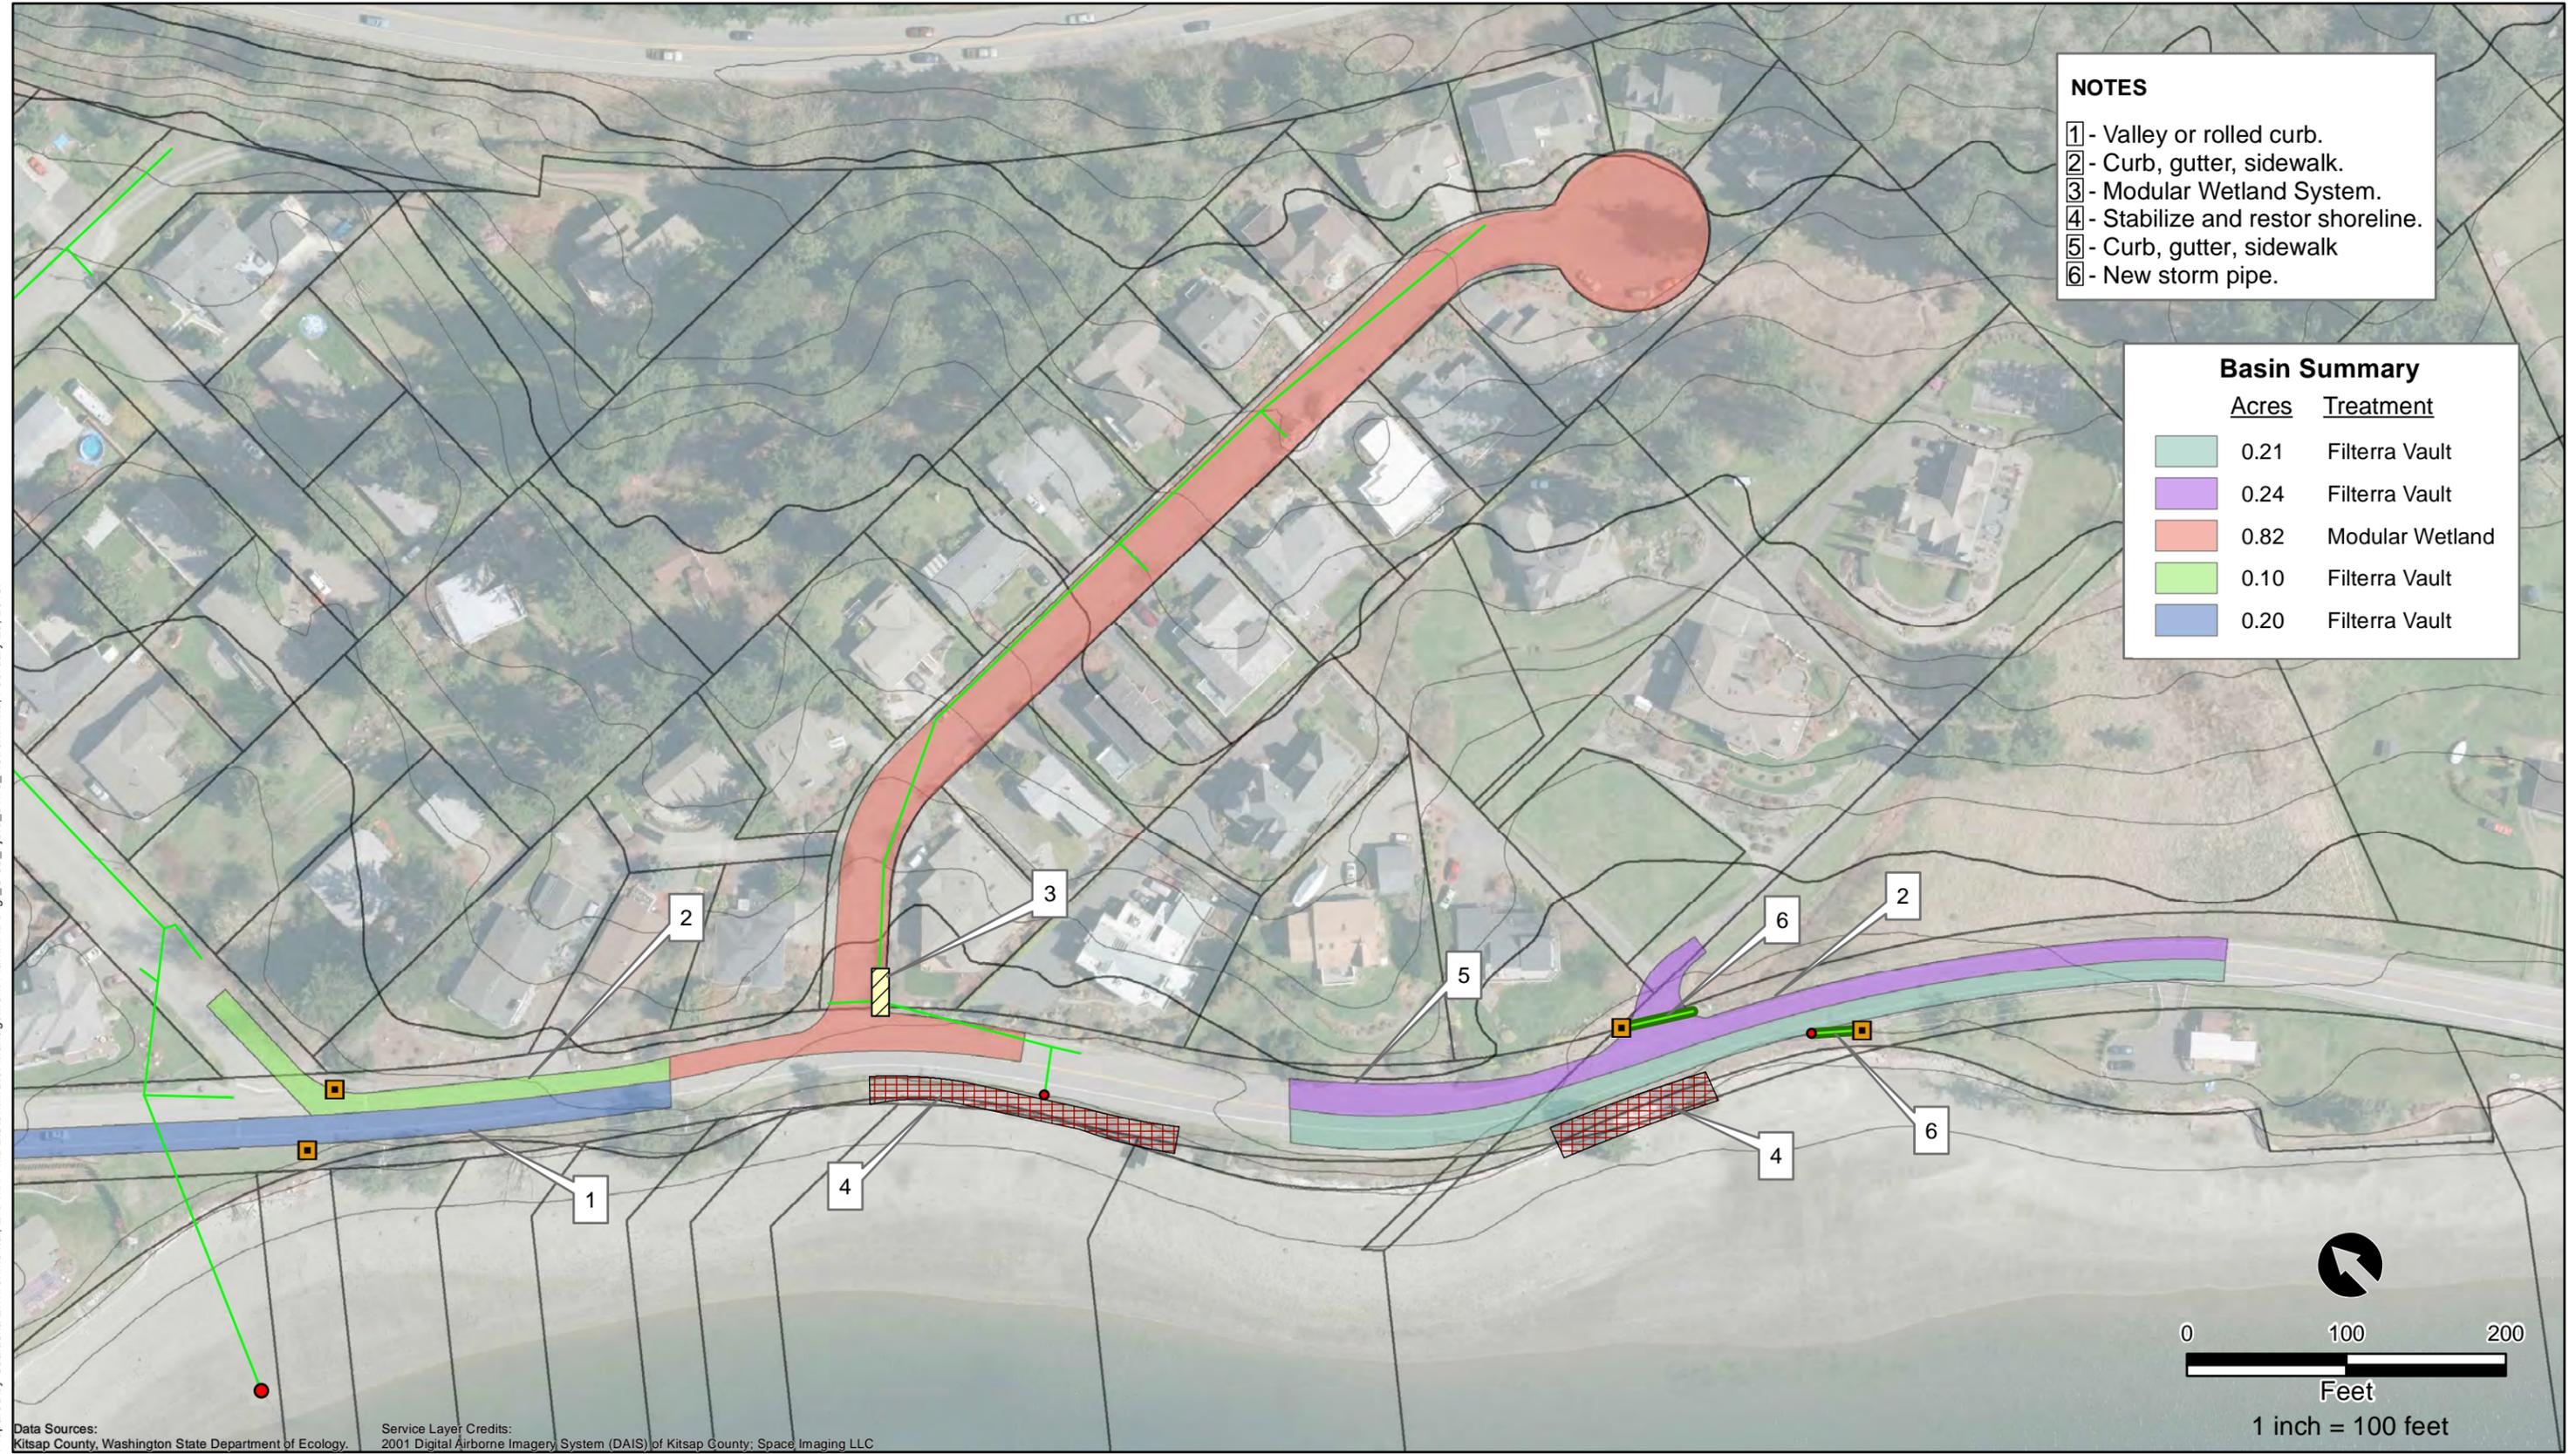
- NOTES**
- 1 - Valley or rolled curb.
  - 2 - Curb, gutter, sidewalk.
  - 3 - Modular Wetland System.
  - 4 - Stabilize and restore shoreline.
  - 5 - Curb, gutter, sidewalk
  - 6 - New storm pipe.

Basin Summary		
Acres	Treatment	
0.21	Filterra Vault	
0.24	Filterra Vault	
0.82	Modular Wetland	
0.10	Filterra Vault	
0.20	Filterra Vault

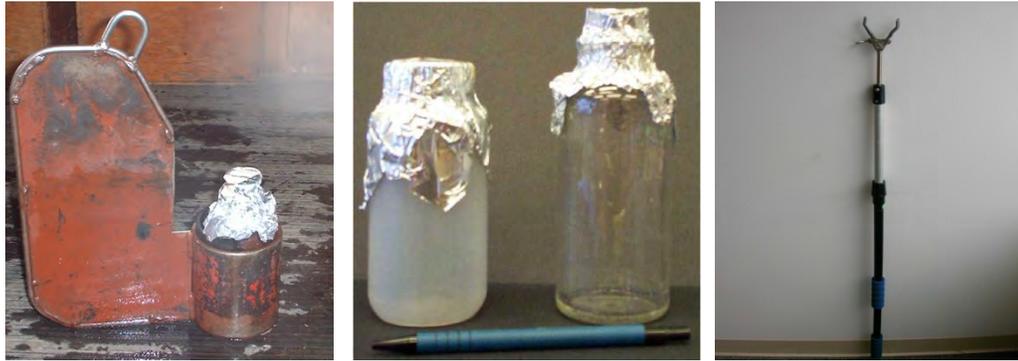
**Figure 1. Left: Bacteria bridge sampler with bottle. Center: 250 mL polypropylene and glass bottles. Right: Sampling extension pole.**

5.1.1 Bacteria bridge sampler (Figure 1 – left)

5.1.3 Extension pole with bottle clamp (Figure 1 – right)

5.1.5 250 or 500 mL autoclaved bacteria sample bottles<sup>1</sup> (Figure 1 – center)

5.2.1 The typical bacteria sample containers are 250-mL or 500mL pre-autoclaved polypropylene bottles with aluminum foil wrapped caps used to preserve sterility near the bottle opening (Figure 1-center). *Note: Masking tape with black lines on the foil mean the bottle was autoclaved. These bottles should not be used after 6 months.*

6.2.3 Be careful not to disturb sediment from the stream bed, particularly in slower moving waters. For slow moving streams with easily disturbed sediment, collect the sample from the stream bank using a sampling extension pole (Figure 1) or from a bridge with a bacteria bridge sampler

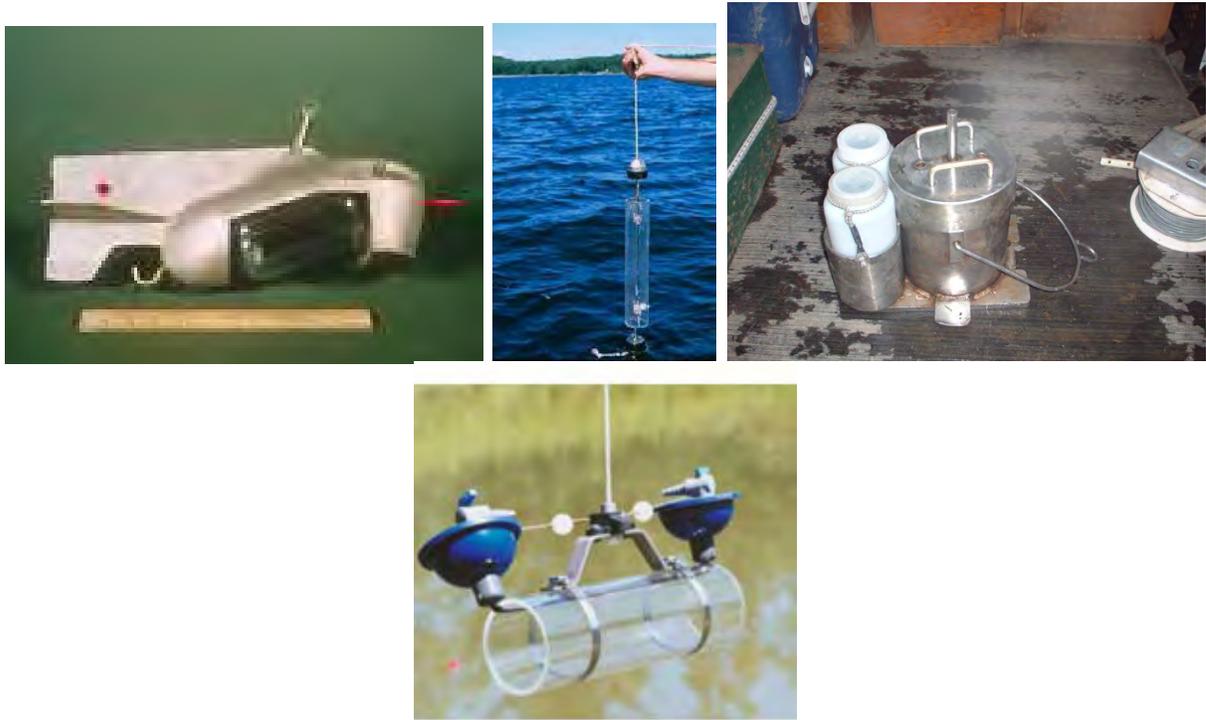
Figure 1. Top: DH-76 integrated sampler with bottle; Kemmerer bottle, weighted bottles and DO bucket for bridge sampling. Bottom: Van Dorn sampler.

- 5.1.1 Intermediate sampling containers and devices (e.g., 500 or 1000 mL bottles, syringe for field filtering, stainless or Teflon dipper, DH-76 integrated sampler, Van Dorn or Kemmerer sampler, appropriate ropes/cables/rods, mobile bridge crane or davit) (Figure 1).

- 6.4.1 Rinse an intermediate container (Figure 1) with site water and pour the rinsate away from or downstream of the sampling location. If used in a contaminated environment (e.g. wastewater treatment plant, stormwater drain), it should be washed with soap and water and rinsed off-site before use. Some organic and micronutrient sampling procedures require acid and distilled water rinses as well. For especially turbid sites, be sure to inspect and rinse out any sediment or organic debris that may have collected at the bottom of the container.

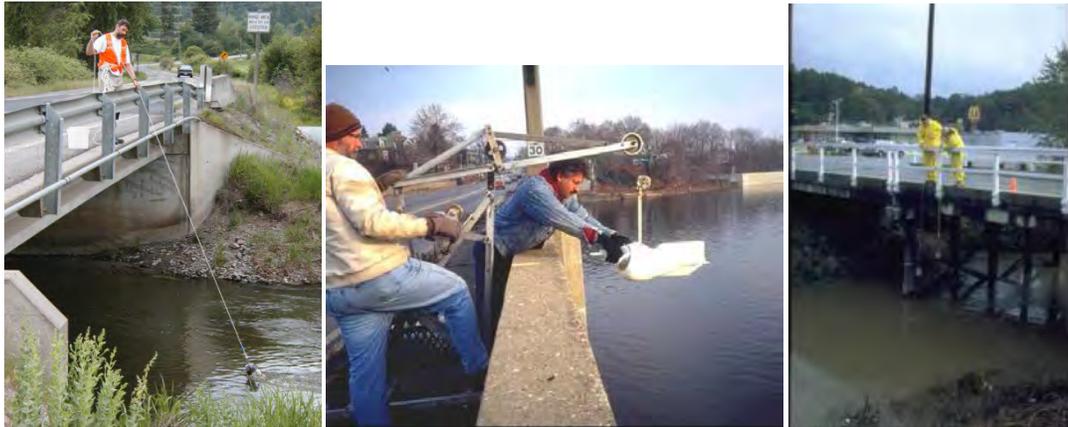
Figure 5. Various methods of collecting water samples from bridges.
