**GEOTECHNICAL ENGINEERING STUDY  
SANDSTONE RIDGE  
LANGAUNET LANE NORTHEAST AND NOLL ROAD NORTHEAST  
POULSBO, WASHINGTON**

**ES-8360.03**

PREPARED FOR  
JKM HOLDINGS, LLC

August 9, 2024

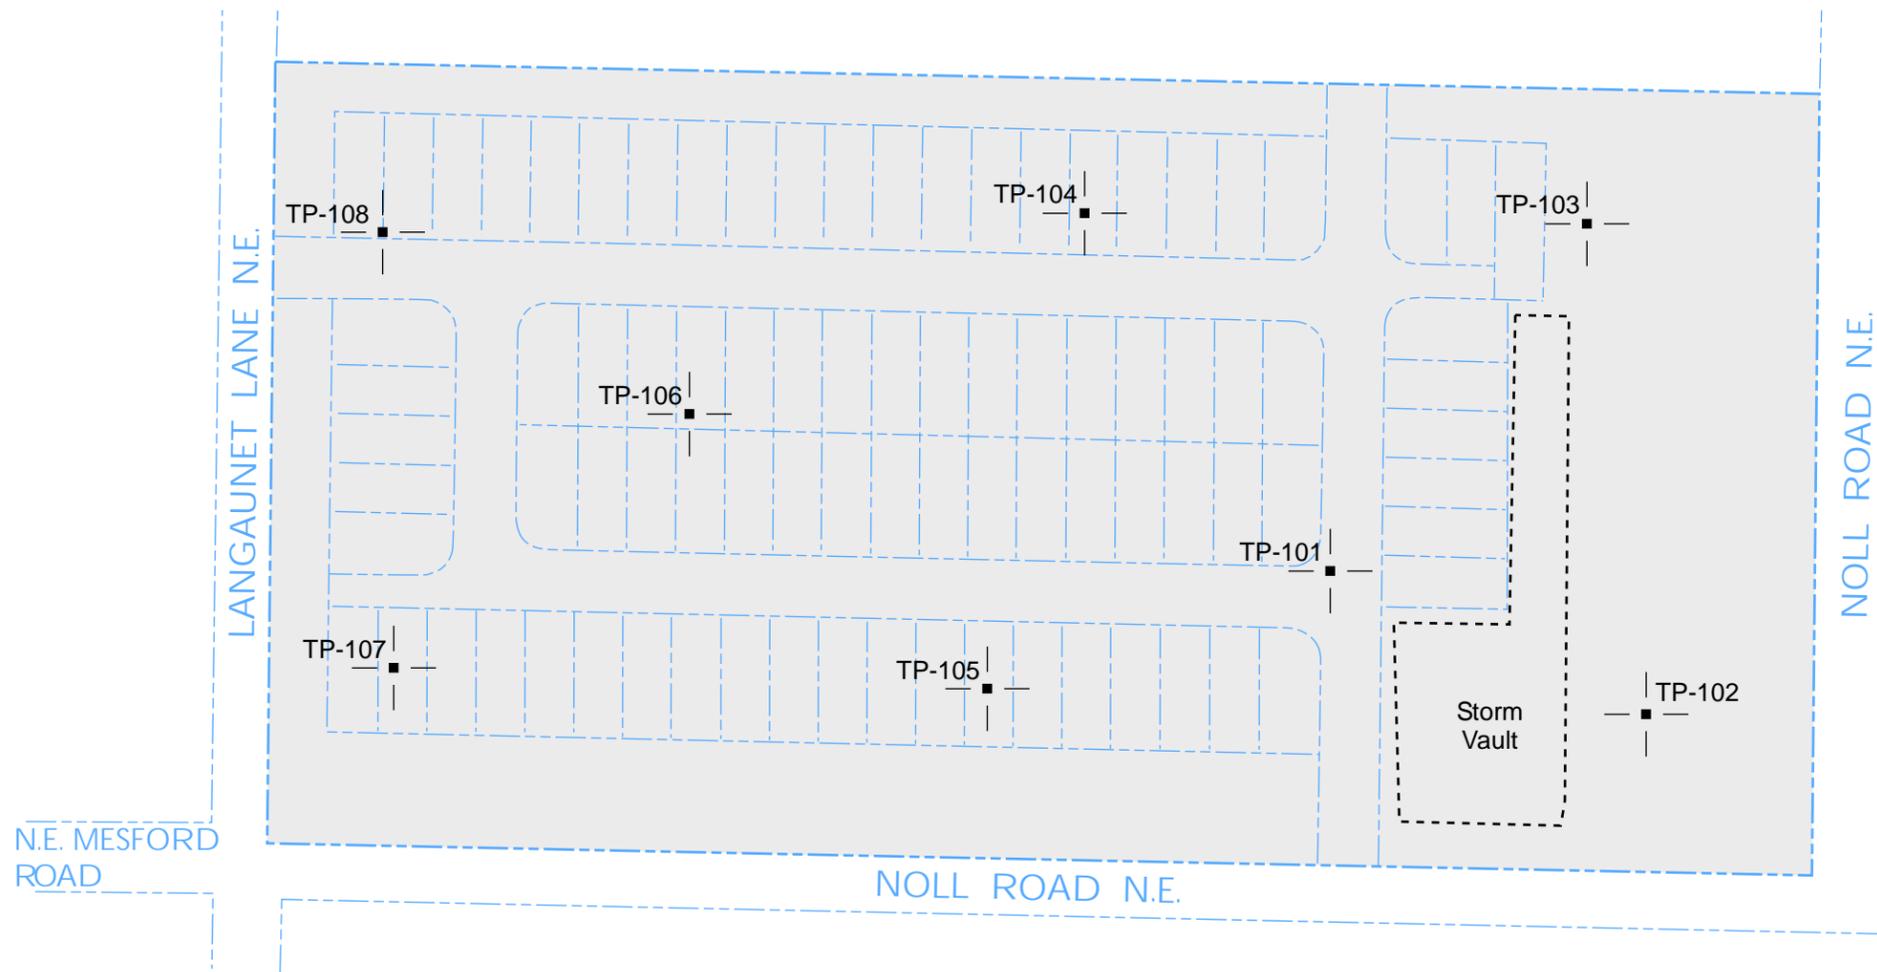
Drawn MRS
Checked SKH
Date 06/17/2024
Proj. No. 8360.03
Plate 2

- TP-101 | ■ | Approximate Location of ESNW Test Pit, Proj. No. ES-8360.03, May 2024
- ▭ | Subject Site

An ESNW representative observed, logged, and sampled the excavation of eight test pits on May 21, 2024. The test pits were excavated within accessible areas of the site using a trackhoe and operator retained by ESNW. The test pits were completed to evaluate, classify, and characterize soil and shallow (observable) groundwater conditions across the subject site. Test pit exploration depths generally ranged from about 7.5 to 10 feet below the existing ground surface (bgs). The approximate locations of the test pits are depicted on Plate 2 (Test Pit Location Plan). Please refer to the test pit logs provided in Appendix A for a more detailed description of subsurface conditions.

ESNW explored on-site soil and groundwater conditions on May 21, 2024. Eight test pits were excavated using a trackhoe and operator retained by ESNW. The test pits were completed within accessible areas of the subject site. The approximate locations of the test pits are illustrated on Plate 2 of this study. The test pit logs are provided in this Appendix. The test pits were excavated to a maximum depth of approximately 10 feet bgs.

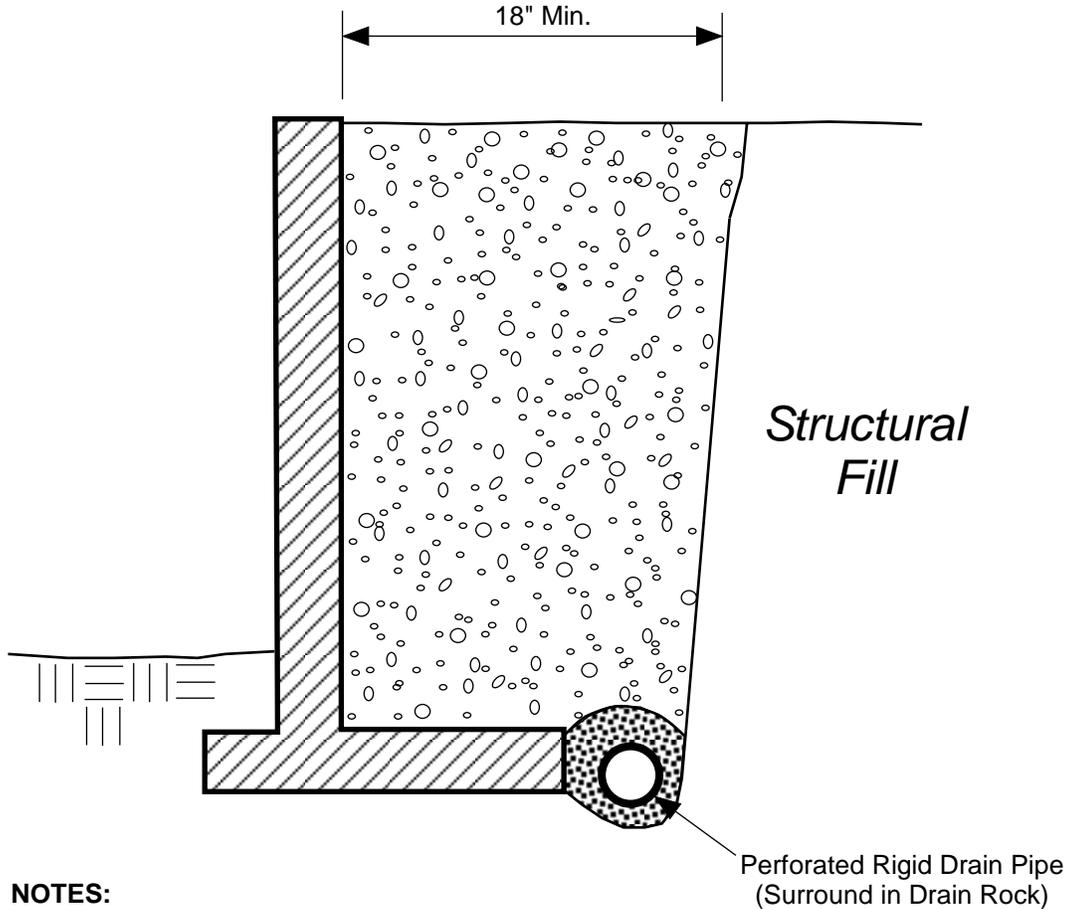
<b>Earth Solutions NW<sub>LLC</sub></b> Geotechnical Engineering, Construction Observation/Testing and Environmental Services	
<b>Retaining Wall Drainage Detail</b> <b>Sandstone Ridge</b> <b>Poulsbo, Washington</b>			
Drawn	MRS	Date	06/17/2024
Proj. No.	8360.03		
Checked	SKH	Date	June 2024
Plate	3

- Free-draining Backfill should consist of soil having less than 5 percent fines. Percent passing No. 4 sieve should be 25 to 75 percent.
- Sheet Drain may be feasible in lieu of Free-draining Backfill, per ESNW recommendations.
- Drain Pipe should consist of perforated, rigid PVC Pipe surrounded with 1-inch Drain Rock.

Drainage should be provided behind retaining walls such that hydrostatic pressures do not develop. If drainage is not provided, hydrostatic pressures should be included in the wall design. A perforated drainpipe should be placed along the base of the wall and connected to an approved discharge location. A typical retaining wall drainage detail is provided on Plate 3.

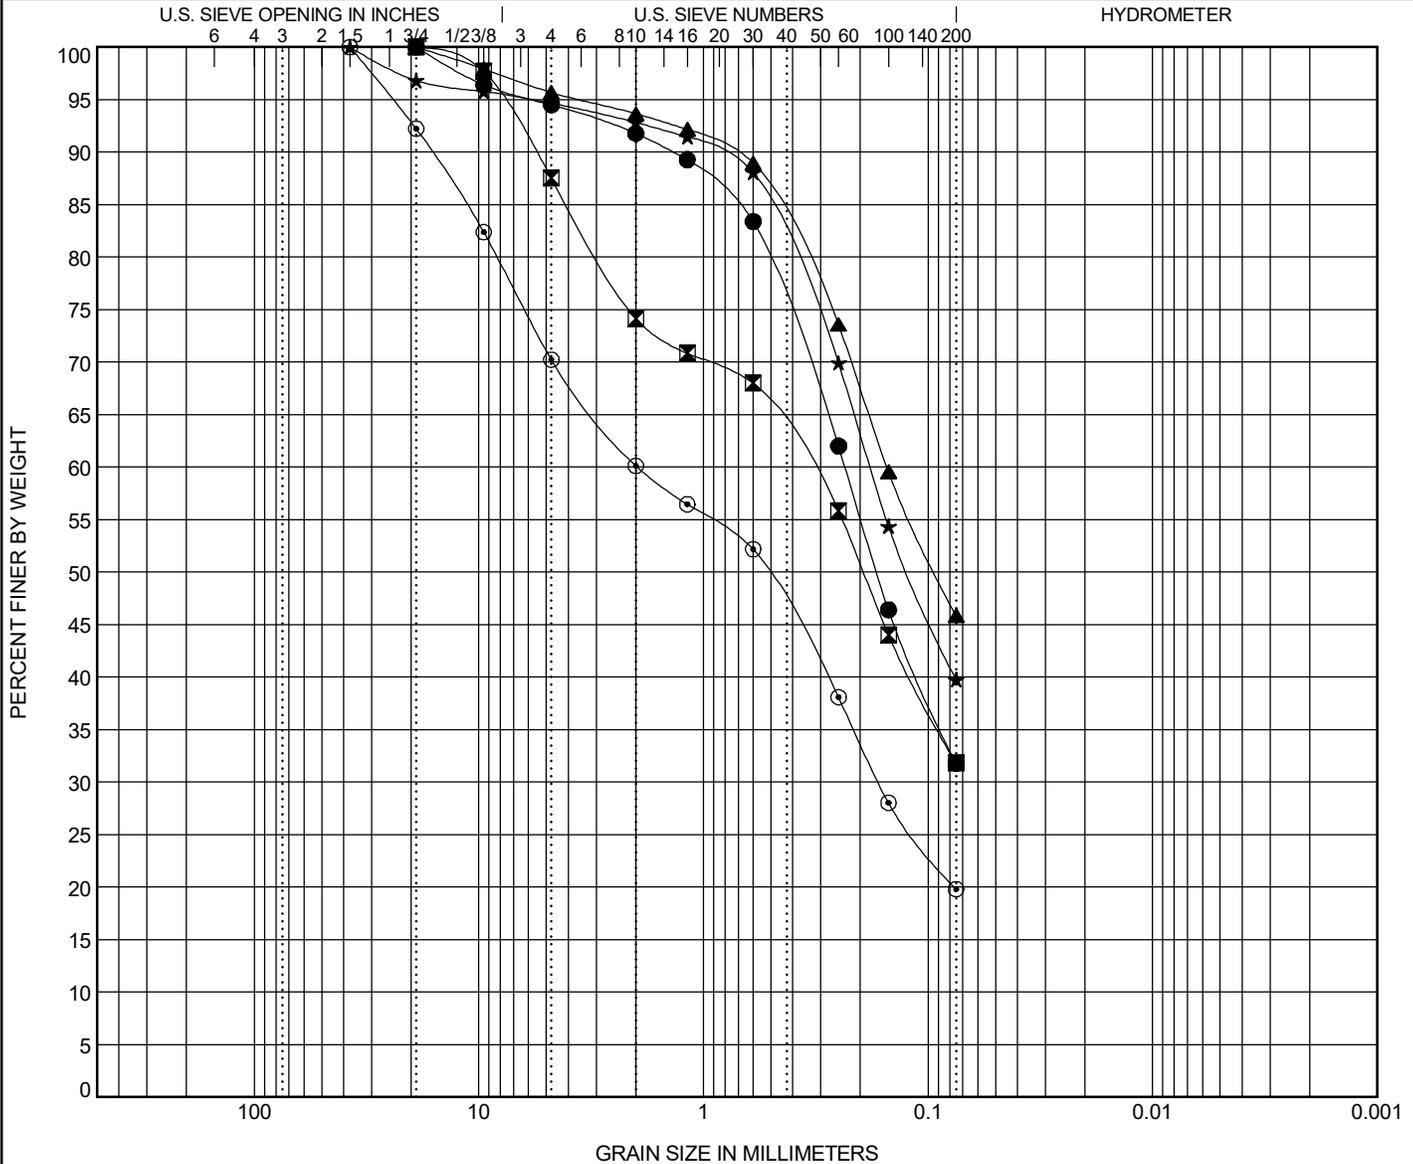
COBBLES	GRAVEL		SAND			SILT OR CLAY
	coarse	fine	coarse	medium	fine

Specimen Identification	Classification							Cc	Cu
● TP-102 10.00ft.	USDA: Gray Slightly Gravelly Sandy Loam. USCS: SM.								
⊠ TP-104 1.50ft.	USDA: Brown Gravelly Fine Sandy Loam. USCS: SM.								
▲ TP-105 9.00ft.	USDA: Gray Slightly Gravelly Fine Sandy Loam. USCS: SM.								
★ TP-106 7.50ft.	USDA: Gray Slightly Gravelly Fine Sandy Loam. USCS: SM.								
⊙ TP-108 2.00ft.	USDA: Brown Very Gravelly Sandy Loam. USCS: SM with Gravel.								
Specimen Identification	D100	D60	D30	D10	LL	PL	PI	%Silt	%Clay
● TP-102 10.0ft.	19	0.234						31.8	
⊠ TP-104 1.5ft.	19	0.337						31.8	
▲ TP-105 9.0ft.	19	0.152						45.9	
★ TP-106 7.5ft.	37.5	0.18						39.8	
⊙ TP-108 2.0ft.	37.5	1.965	0.166					19.8

Representative soil samples collected at the test pit locations were analyzed for moisture content and grain size distribution in general accordance with both Unified Soil Classification System (USCS) and United States Department of Agriculture (USDA) methods and procedures. Results of laboratory analyses are provided in Appendix B.
