Re: Geotechnical Engineering Report - Addendum

Johnson Residential Development
Kitsap County Parcel Numbers: 242601-3-018-2001, 242601-3-005-2006, and 242601-3-019-2000
Poulsbo, Washington
Project No. AS240561-03

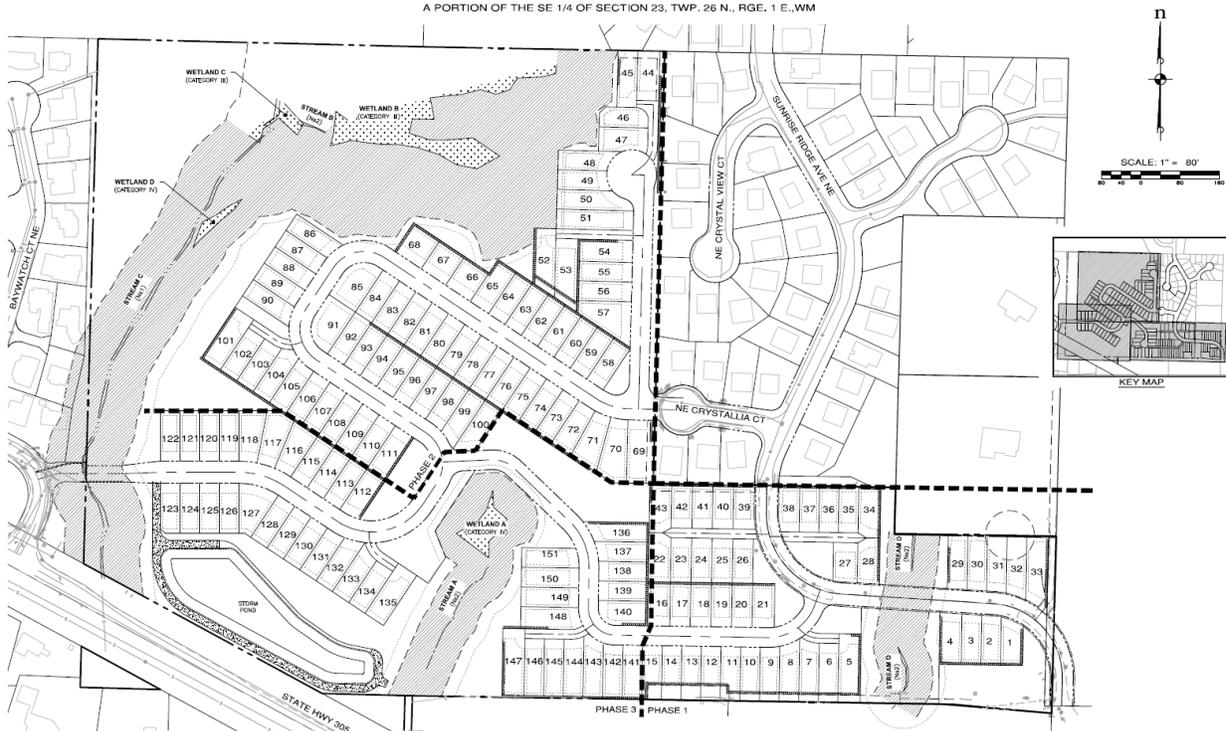
Graphic 1. Current Project Plans (ESM, 2025)

Current project plans for the Owl Ridge Parcels include about 26 residential parcels, a connector roadway from Sunrise Ridge Avenue NE from the northern property line near the northwest corner that will extend through the properties to the southern property line near the southeast corner, and associated utilities and infrastructure (Graphic 1; ESM, 2025).

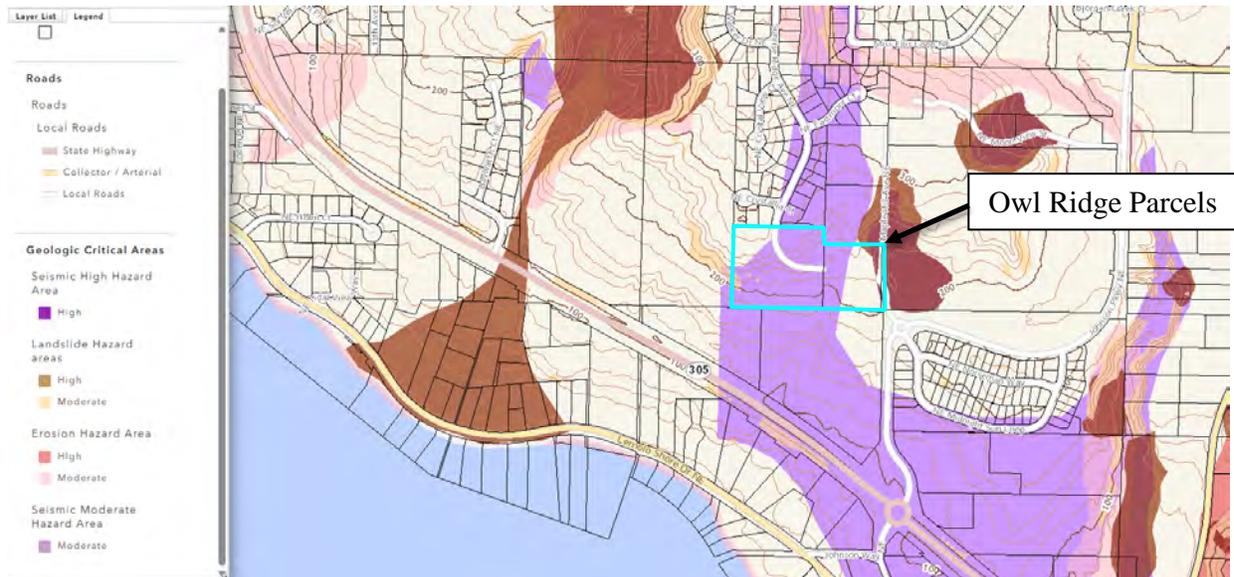
Graphic 2. County Geologic Hazards Map (County, 2025)

The County’s geologic hazard map designates four hazards on the Owl Ridge Parcels (Graphic 2 below):

- A high landslide hazard, defined as steeper than 30 percent slopes, is present along the east side of the parcels.
- A limited area of moderate landslide hazard, defined as slopes between 15 to 30 percent is along the west property line, extending onto the previously evaluated property.
- A moderate seismic hazard covers a large area through the middle and east side of the parcels.

Three geologic hazards are mapped on and within the area of influence of the Owl Ridge Parcels including: high landslide hazard, moderate landslide hazards, and a moderate seismic hazard (Graphic 1). The seismic hazard shape matches the mapped extents of Esperance Sand Member on the geologic map. None of the materials encountered are liquefiable, thus soil liquefaction is not a seismic hazard or design consideration.

The moderate landslide hazard area along the western boundary was fully evaluated during our previous work and we concluded that the area was stable and no setback from the area was needed.

The high landslide hazard along the eastern boundary matches the shape of the deep-seated rotational landslide noted on the geologic and geomorphic maps. Our test pits closest to that boundary did not encounter landslide deposits. It is our opinion that this landslide is currently dormant; therefore, we do NOT recommend a minimum setback from the area; however, this area should be closely monitored during construction by us to confirm no landslide deposits are encountered.

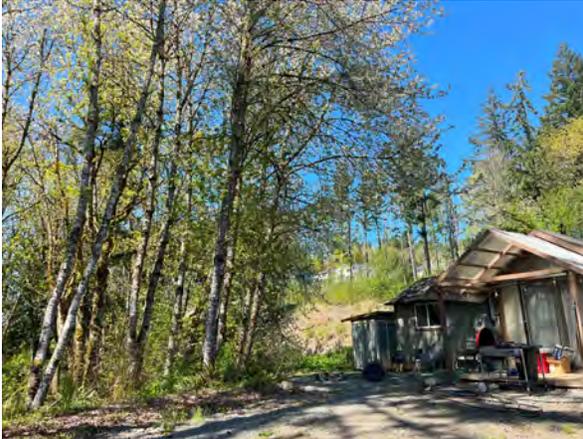
Photograph 1. Existing Residence on central parcel, view to the northwest, on April 17, 2025.

The central parcel is developed with a one-story, 577-square-foot residence built in 1935 with a gravel access driveway from the south, near the central area of the parcel (Photograph 1). A stormwater pond is located in the southeast corner of the central parcel (Photograph 2).

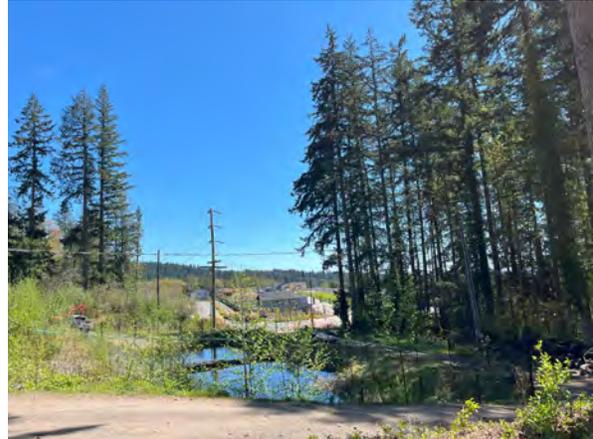
Photograph 2. Stormwater pond in southeast corner of central parcel, view to the east, on April 17, 2025.

Water was observed in the stormwater pond. Outside the pond, no water seepage, springs, flowing water, evidence of past standing or flowing water, hydrophilic vegetation, or saturated soils were observed.

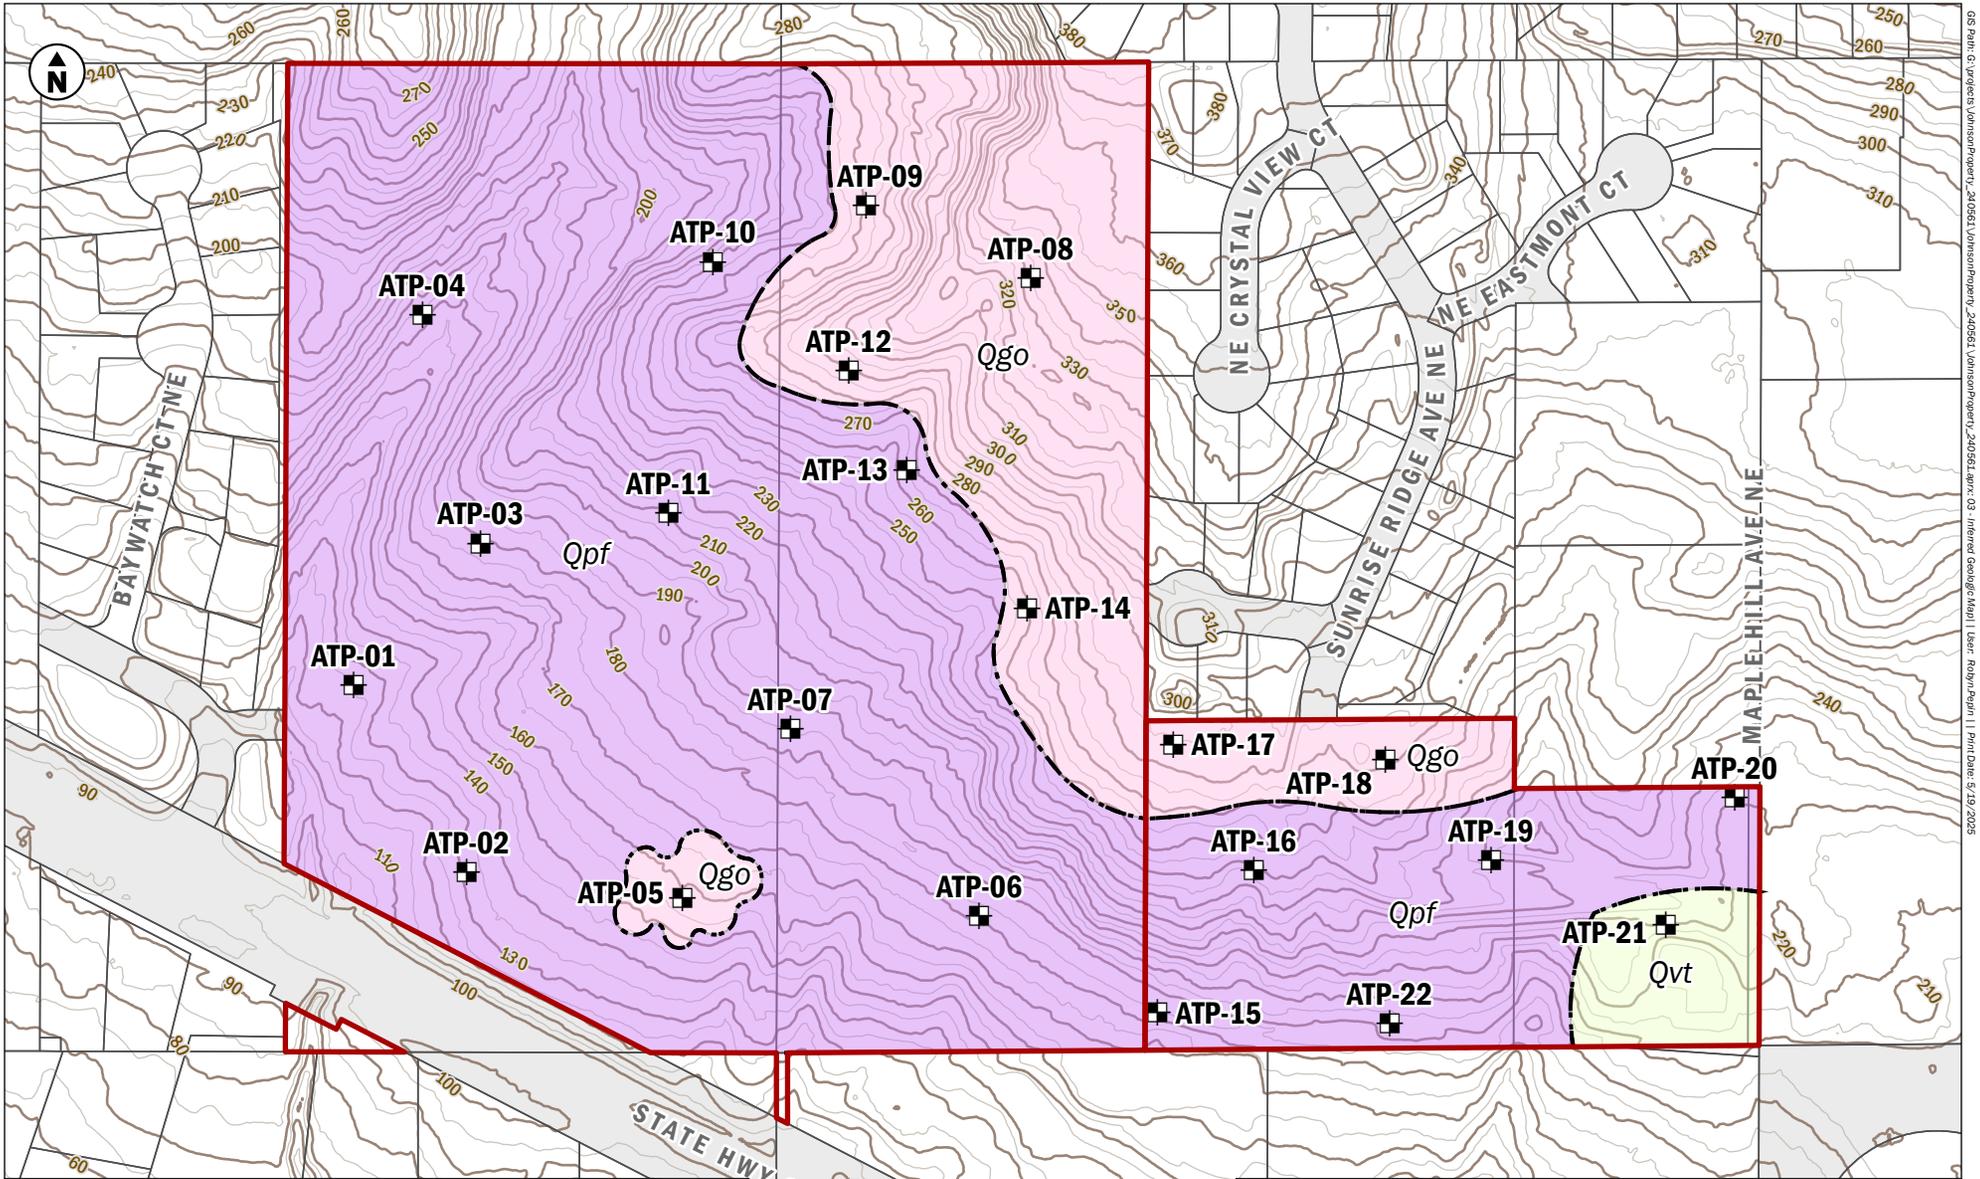
On April 17, 2025, we oversaw the advancement of eight (8) test pits, designated ATP-15 through ATP-22, which terminated between 6 and 11 feet below ground surface (bgs). Detailed descriptions of the subsurface conditions and soil characteristics are provided in the exploration logs in Appendix A. The locations of the test pits are shown on Figure 2.

- Aspect Test Pit
- Site Boundary
- Kitsap County Parcels
- Topo Contours 5ft
- Topo Contours 10ft
- Inferred Geologic Contact
- Vashon Recessional Outwash (Qgo)
- Glaciolacustrine Deposits, part of the Pre-Vashon Fines Unit (Qpf)
- Vashon Till (Qvt)

On April 17, 2025, Aspect observed the excavation of eight test pits, ATP-15 through ATP-22. The test pits were excavated by an excavation company provided by you. Test pits were excavated using a Kubota KX040-U tracked excavator. An Aspect representative, Chelsea Bush, LG, was present throughout the field exploration program to determine the locations of the explorations, observe the explorations, assist in sampling, and to prepare descriptive logs of each exploration. Samples were obtained from select soil units to aid in the determination of engineering properties of the subsurface materials and laboratory testing. The locations of explorations are shown on Figure 2 and were collected with a Global Positioning System (GPS).

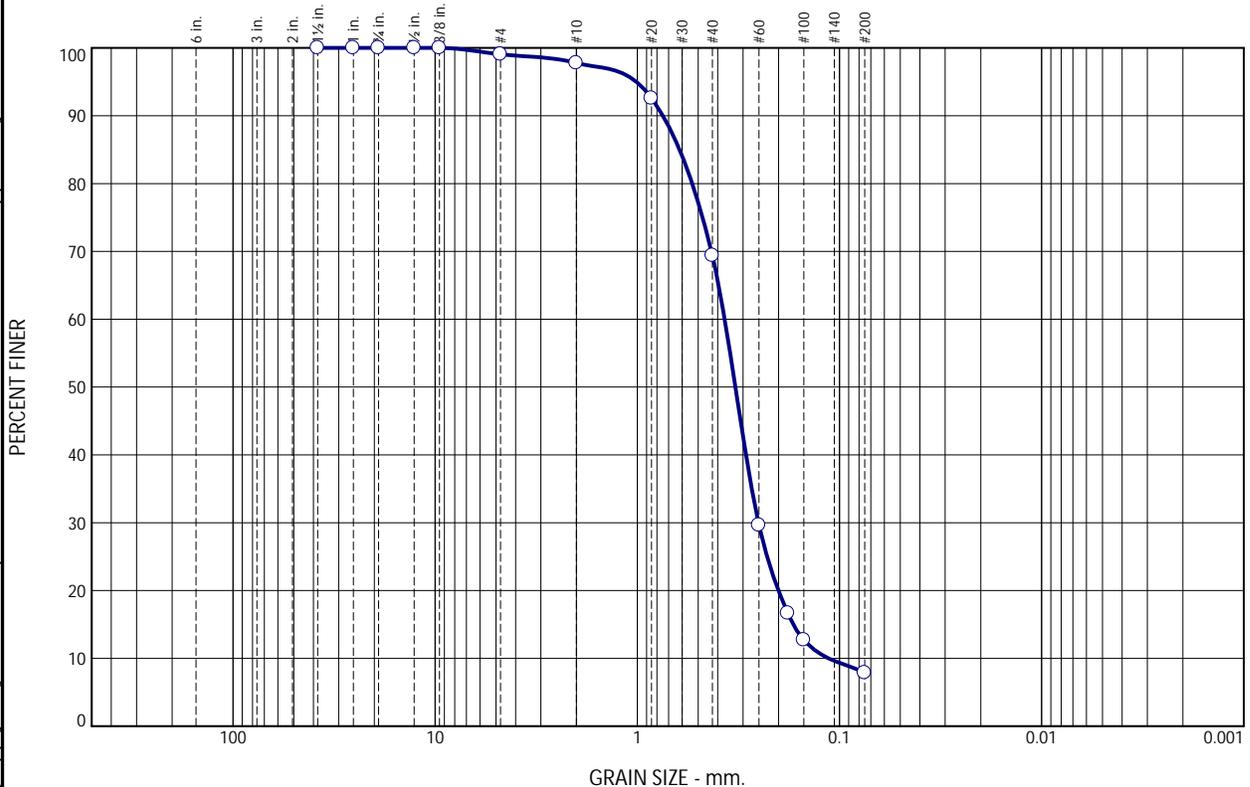
Particle Size Distribution Report

% +3"	% Gravel		% Sand			% Fines	
	Coarse	Fine	Coarse	Medium	Fine	Silt	Clay
0	0	1	1	29	61	8

Test Results (ASTM C117 & C136)				
Sieve Size or Diam. (mm.)	Finer (%)	Spec. * (%)	Out of Spec. (%)	Pct. of Fines
1 1/2	100			
1	100			
3/4	100			
1/2	100			
3/8	100			
#4	99			
#10	98			
#20	93			
#40	69			
#60	30			
#80	17			
#100	13			
#200	7.8

Test Remarks
 As Received Moisture: 12.6%
 F.M.=1.67

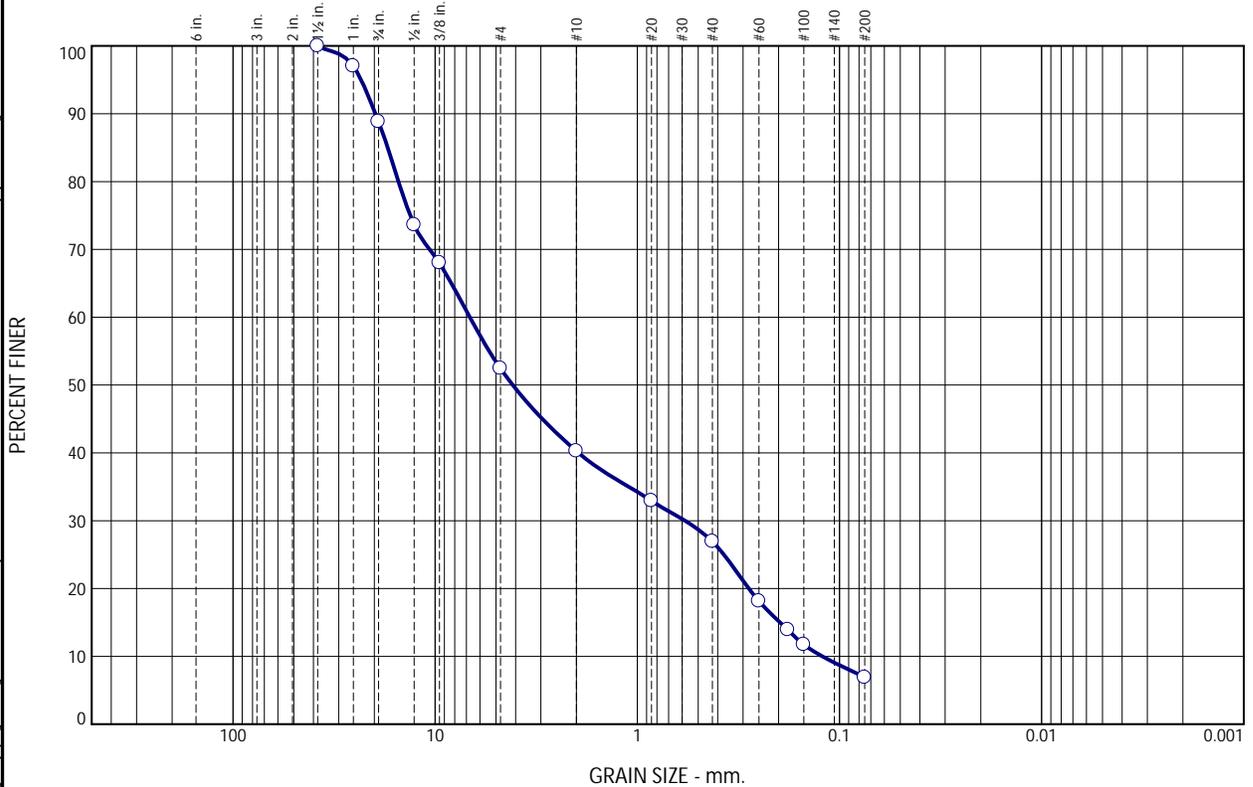
Particle Size Distribution Report

% +3"	% Gravel		% Sand			% Fines	
	Coarse	Fine	Coarse	Medium	Fine	Silt	Clay
0	11	37	12	13	20	7

Test Results (ASTM C117 & C136)				
Sieve Size or Diam. (mm.)	Finer (%)	Spec. * (%)	Out of Spec. (%)	Pct. of Fines
1 1/2	100			
1	97			
3/4	89			
1/2	74			
3/8	68			
#4	52			
#10	40			
#20	33			
#40	27			
#60	18			
#80	14			
#100	12			
#200	6.9

As Received Moisture: 3.8%
F.M.=4.50

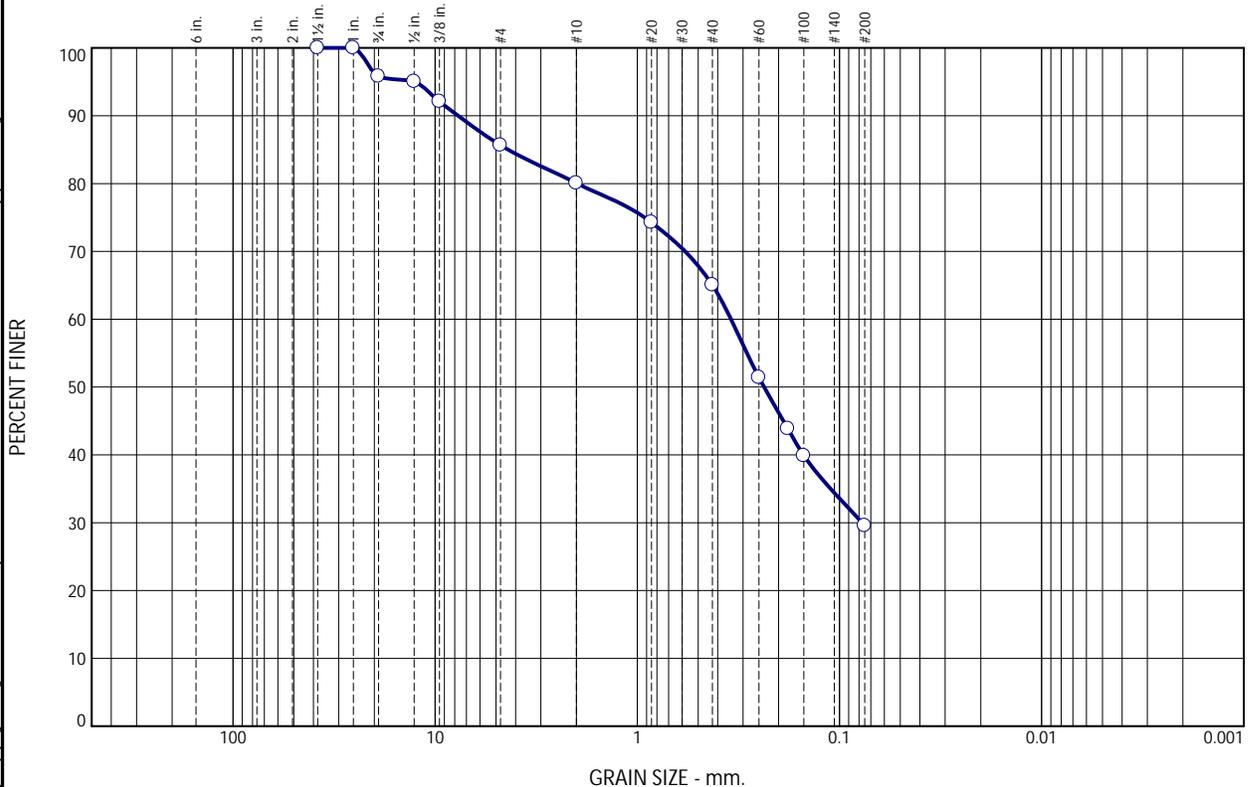
Particle Size Distribution Report

% +3"	% Gravel		% Sand			% Fines	
	Coarse	Fine	Coarse	Medium	Fine	Silt	Clay
0	4	10	6	15	35	30

Test Results (ASTM C117 & C136)				
Sieve Size or Diam. (mm.)	Finer (%)	Spec. * (%)	Out of Spec. (%)	Pct. of Fines
1 1/2	100			
1	100			
3/4	96			
1/2	95			
3/8	92			
#4	86			
#10	80			
#20	74			
#40	65			
#60	51			
#80	44			
#100	40			
#200	30

As Received Moisture: 7.9%
F.M.=2.02

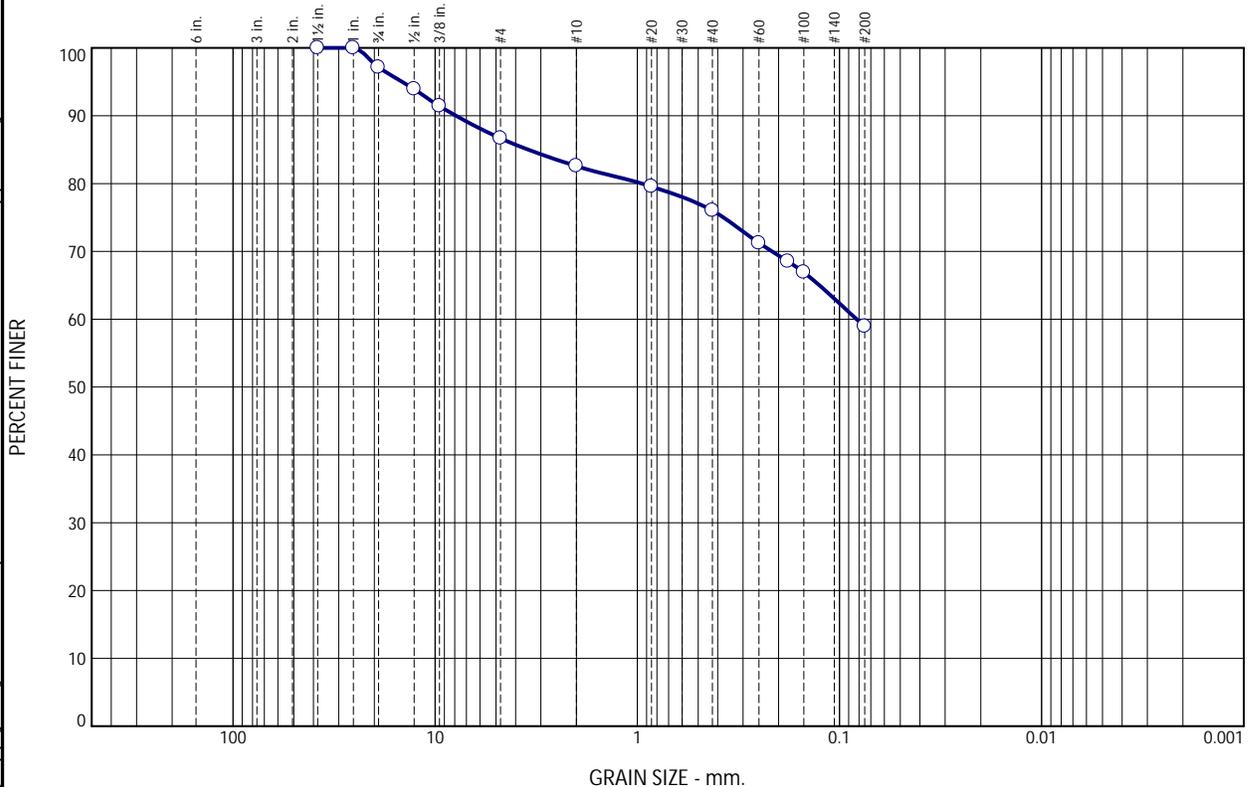
Particle Size Distribution Report

% +3"	% Gravel		% Sand			% Fines	
	Coarse	Fine	Coarse	Medium	Fine	Silt	Clay
0	3	10	4	7	17	59

Test Results (ASTM C117 & C136)				
Sieve Size or Diam. (mm.)	Finer (%)	Spec. * (%)	Out of Spec. (%)	Pct. of Fines
1 1/2	100			
1	100			
3/4	97			
1/2	94			
3/8	91			
#4	87			
#10	83			
#20	80			
#40	76			
#60	71			
#80	69			
#100	67			
#200	59

As Received Moisture: 14.1%
F.M.=1.43
