GEOTECHNICAL ENGINEERING REPORT

Johnson Residential Development

Poulsbo, Washington

Project No. AS240561-02 • February 13, 2025 FINAL

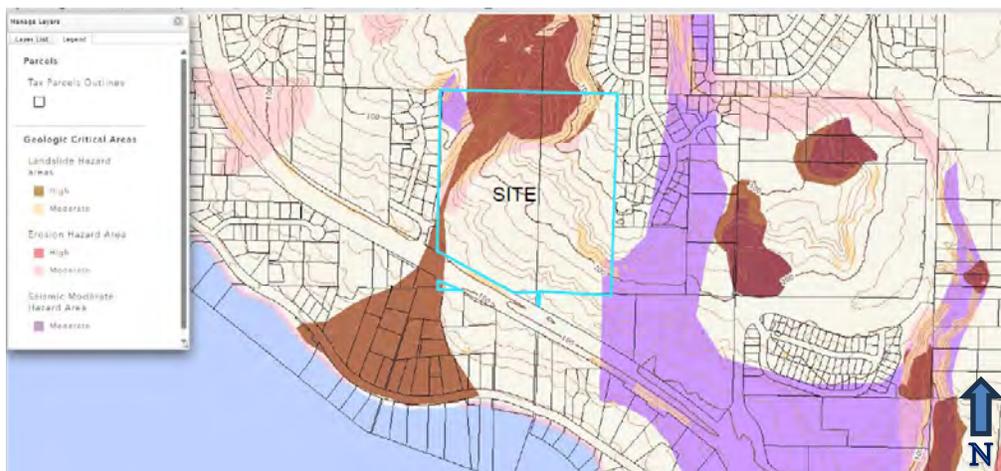
Graphic 1. County Geologic Hazards Map (County, 2024)

The County’s geologic hazard map designates four hazards on the Site (Graphic 1 below):

- High landslide hazard, defined as steeper than 30 percent slopes
- Moderate landslide hazard, defined as slopes between 15 to 30 percent
- A moderate erosion hazard
- A moderate seismic hazard

The high and moderate landslide hazards and erosion hazard are mapped along a roughly north-to-south trending ravine trending from the northwest to the southwest portion of the Site. The moderate erosion hazard is in the northwest portion of the Site. The moderate seismic hazard is mapped in the northwest corner of the Site. Moderate slopes are also mapped on slopes in the southeast portion of the Site. The Site is not mapped as or within the zone of influence (300 feet) of a liquefaction hazard or fault zone.

Four geologic hazards are mapped on and within the area of influence of the Site including: high landslide hazard, moderate landslide hazards, moderate erosion hazards, and a moderate seismic hazard (Graphic 1). The high landslide hazard, moderate erosion hazard, and the moderate seismic hazard are all located in the northwest corner of the Site, in a ravine area with a mapped non-fish habitat watercourse at the base. No development is planned on or within 100 feet of these mapped hazards. Based on our data review, reconnaissance, subsurface explorations, and our understanding of the Project, no additional setbacks are recommended.

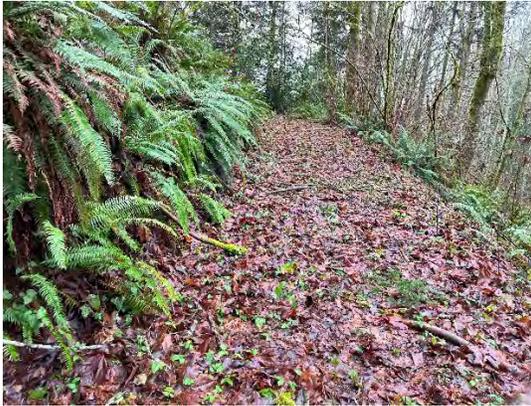
Photograph 1. Unpaved trail at the Site, view to the east.

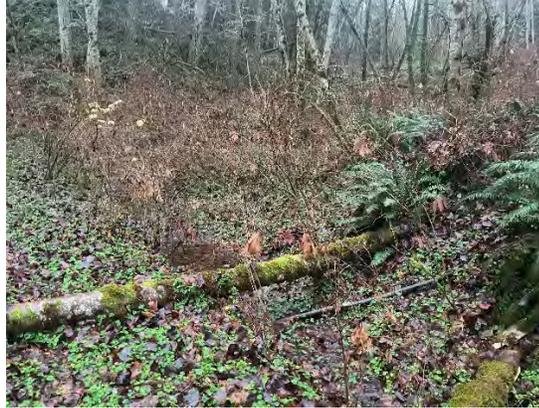
We observed areas of standing water in the ravine drainage along the west side of the Site, and areas of very saturated soils along the southern property boundary (Photograph 2). We noted several 6-inch-diameter, smooth-walled plastic pipes running underneath portions of the trail system that moved water downslope. Surface drainage conditions, as well as groundwater conditions at the Site, will vary with fluctuations in precipitation, Site usage (such as irrigation), and off-Site land use.

Photograph 2. Area of standing water in the southwest portion of the Site, north of State Highway 305, view to the north.

The presence of relatively impermeable glaciolacustrine deposits combined with our observations of surface water on the west side of the Site, concentrated stormwater infiltration is infeasible at the Site. We recommend stormwater management be accomplished using low impact development (LID) methods combined with conventional methods, including catch basins and storm drainpipes that discharge into an appropriate system. LID methods, such as small raingardens, bioswales, and dispersion, are feasible provided the systems incorporate underdrains and/or overflow redundancy to account for the low permeability and low-infiltration capacity of the Site soils.

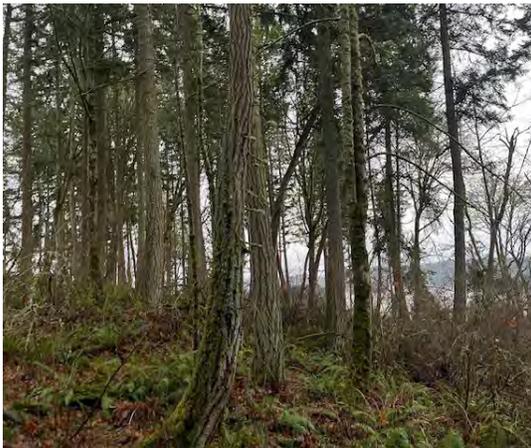
The Site is generally vegetated with mature evergreens up to 40 inches diameter at breast height, young to mature alder, fern, and woody underbrush. Limited numbers of evergreens located on the slopes had slight trunk curvature, indicating some soil movement over time (Photograph 3). The central and southern portion of the Site and within the ravine drainage along the west side of the Site is vegetated with young to mature alder, dense understory of blackberry, and woody underbrush (Photograph 4). We observed horsetail in the south portion of the Site, indicating the presence of saturated soils. Within the ravine drainage in the northwest portion of the Site we observed tilted and downed alders.

Photograph 3. Vegetation at the Site, view to the south.

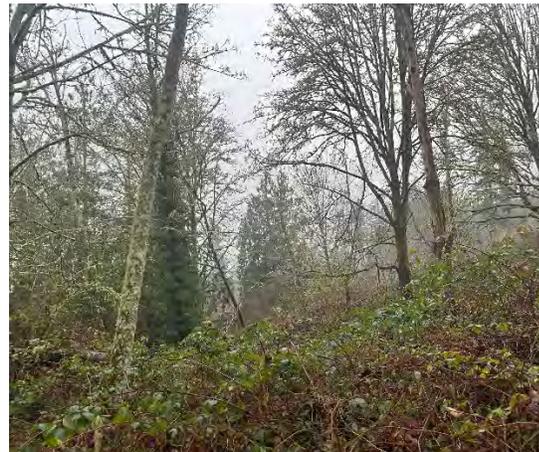
Photograph 4. Vegetation in the southern portion of the Site, view to the north.

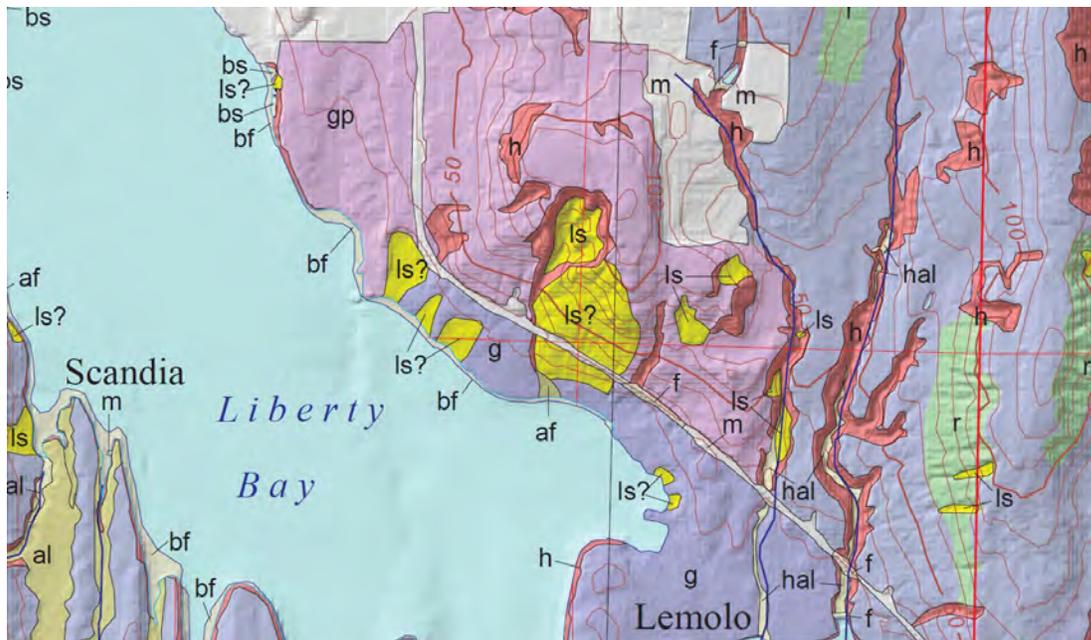
Graphic 2. Geomorphic Map Indicating a Possible Deep-Seated, Rotational Landslide (Haugerud, 2009)

- Aspect reviewed the newest publicly available LiDAR data for the Site and surrounding area (DNR, 2018), which shows bowl-shaped topography and hummocky terrain in the northwest portion of the Site, which may indicate a historic landslide in the ravine but lacks the surface roughness to indicate recent slide activity southeast of this area on the Site.

The north- and northwest-facing slopes of the ravine in the northwest portion of the Site have indicators of slope movement, including bowl-shaped topography, hummocky terrain, and tilted and downed trees. If these are landslide areas, the failures would occur to the north and northwest, at least 100 feet from the area of planned development. It is our opinion a 100-foot setback distance from the top of the slope will be adequate for the planned development.

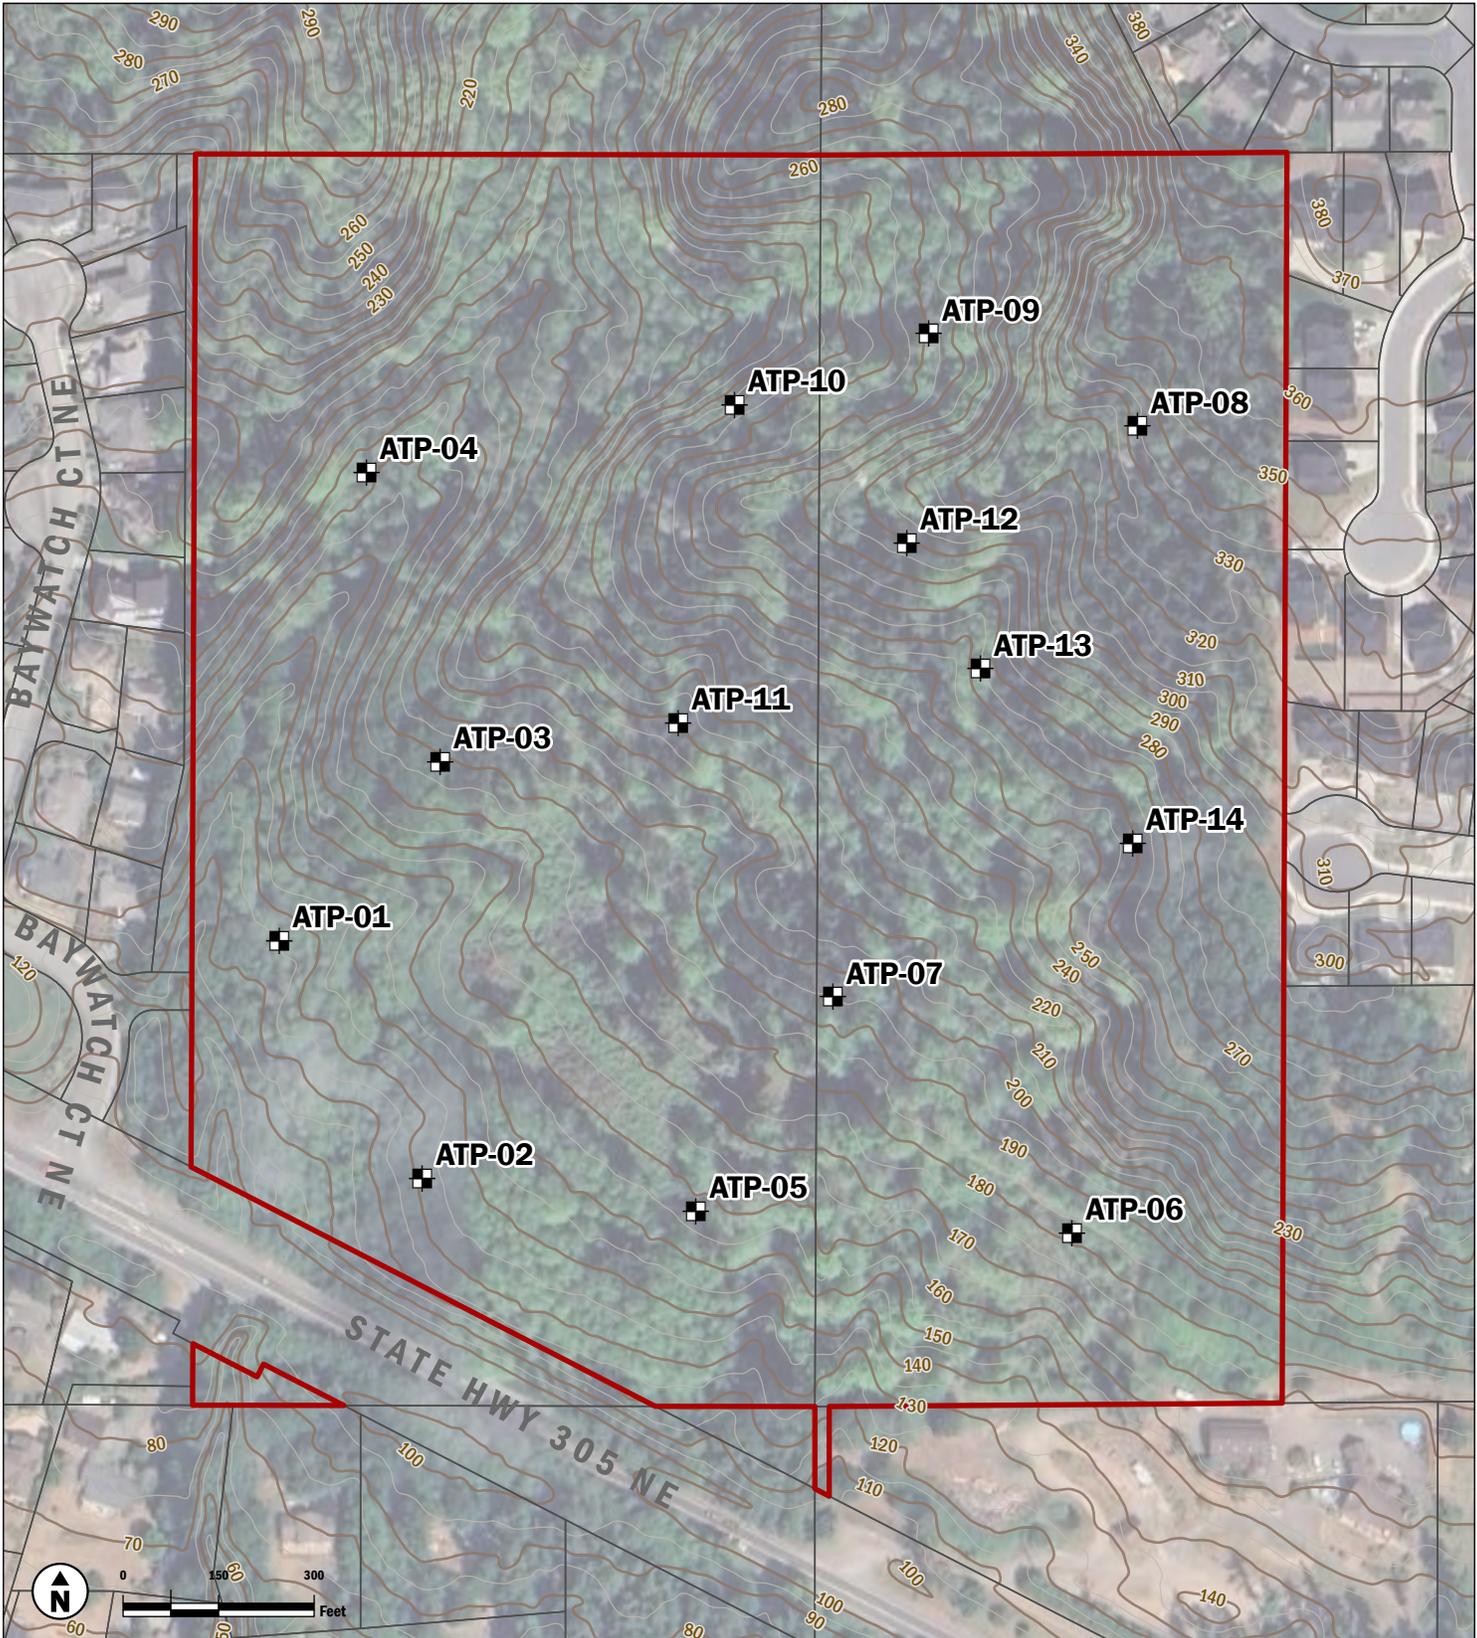
JAN-2025	BY: AJD / HMD	FIGURE NO. 2
	PROJECT NO. 240561	REVISED BY: - - - / - - -

On January 2 and 3, 2025, Aspect oversaw the advancement of 14 test pits, designated ATP-01 through ATP-14, terminated between 10 and 13 feet below ground surface (bgs). Detailed descriptions of the subsurface conditions and soil characteristics are provided in the exploration logs in Appendix A. The locations of the test pits are shown on Figure 2.

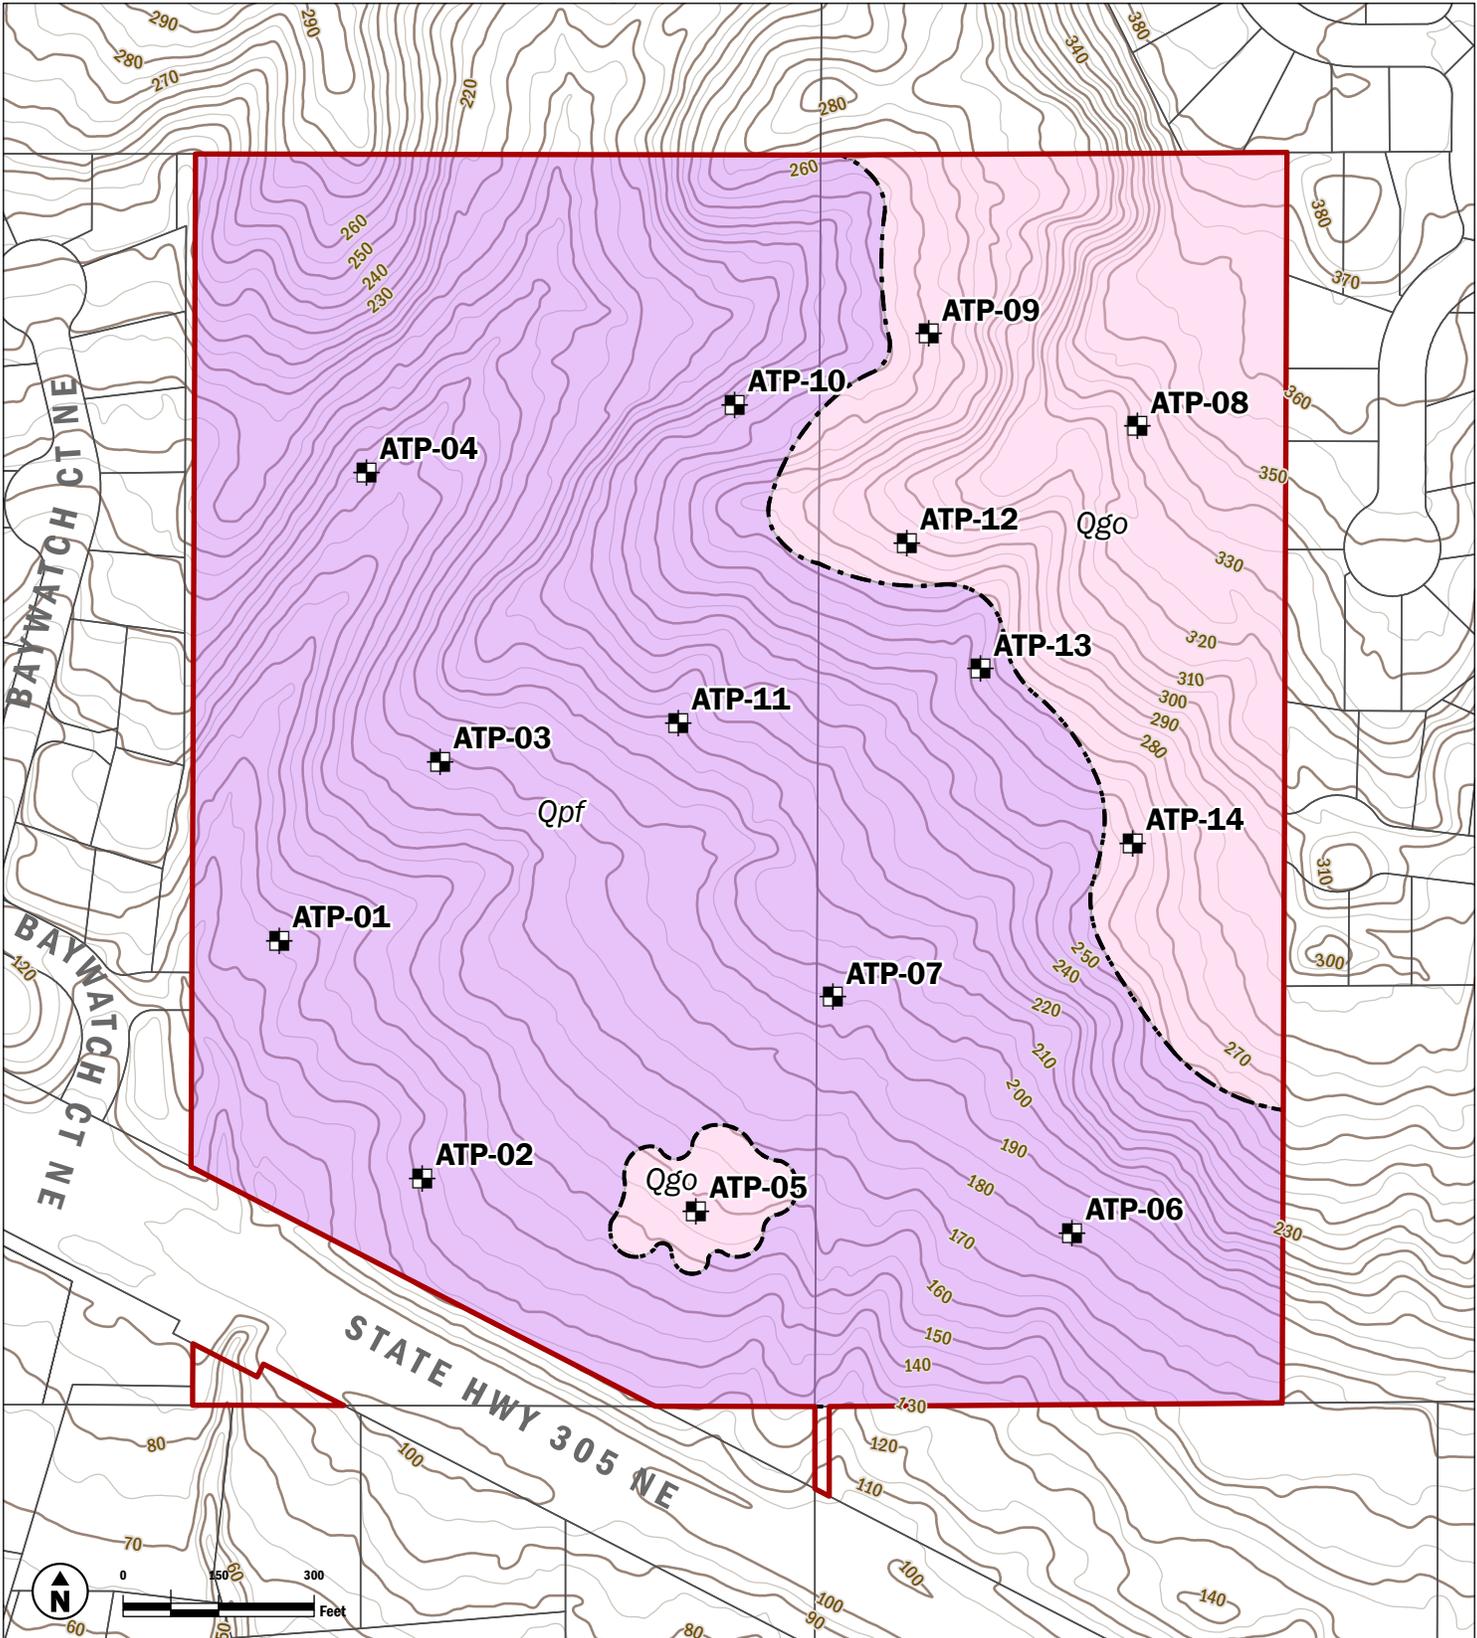
Inferred Geologic Map

- Aspect Test Pit
- Site Boundary
- Kitsap County Parcels
- Topo Contours 5ft
- Topo Contours 10ft
- Inferred Geologic Contact
- Vashon Recessional Outwash (Qgo)
- Glaciolacustrine Deposits, part of the Pre-Vashon Fines Unit (Qpf)

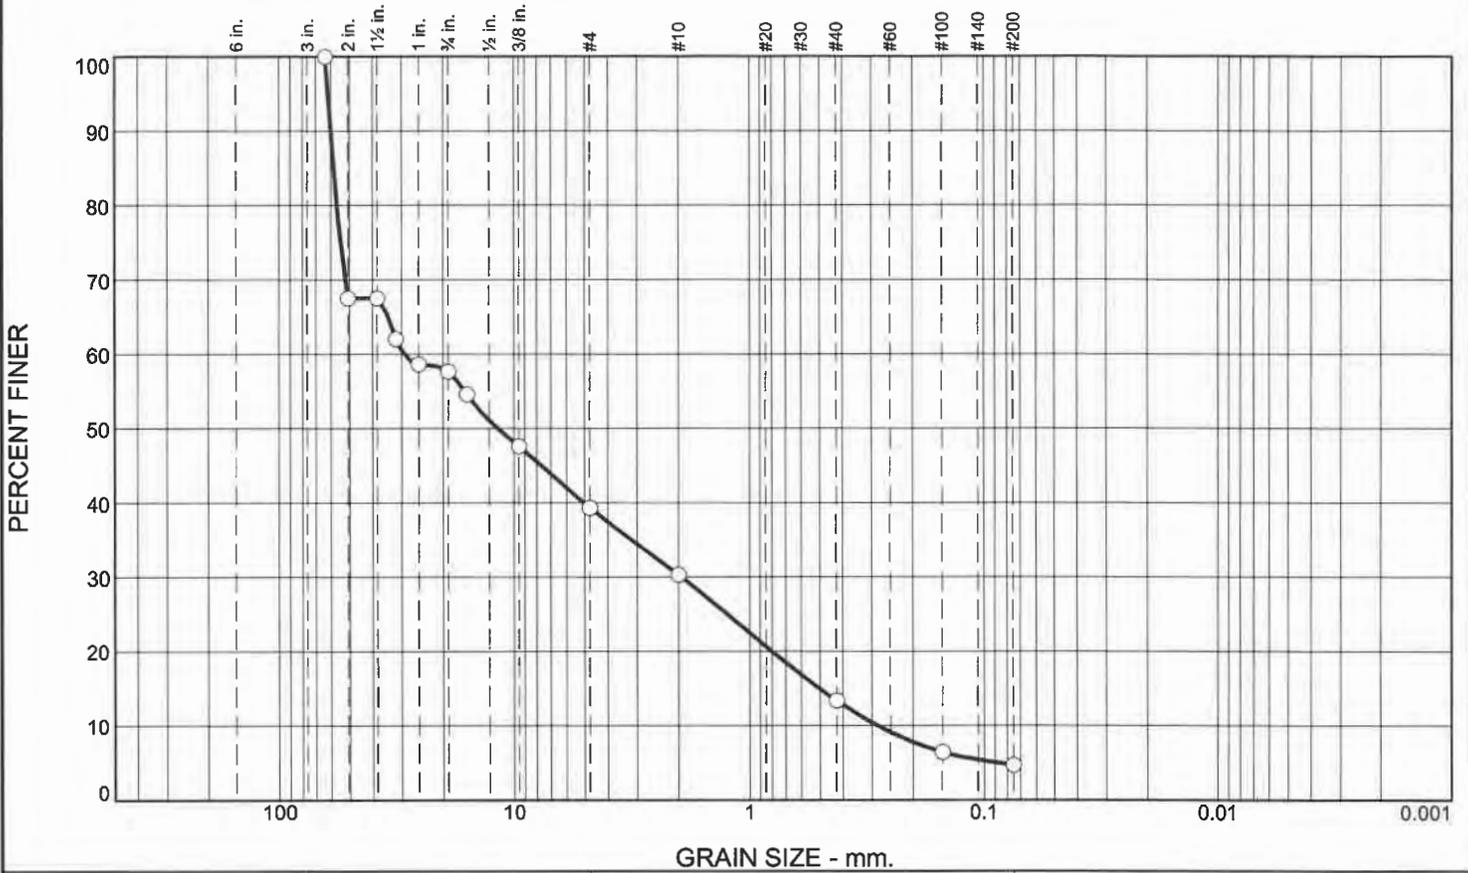
Particle Size Distribution Report

% +3"	% Gravel		% Sand			% Fines	
	Coarse	Fine	Coarse	Medium	Fine	Silt	Clay
0.0	42.3	18.4	9.0	16.9	8.7	4.7

SIEVE SIZE	PERCENT FINER	SPEC.* PERCENT	PASS? (X=NO)
2 1/2"	100.0		
2"	67.5		
1 1/2"	67.5		
1 1/4"	62.0		
1"	58.7		
3/4"	57.7		
5/8"	54.6		
3/8"	47.6		
#4	39.3		
#10	30.3		
#40	13.4		
#100	6.5		
#200	4.7

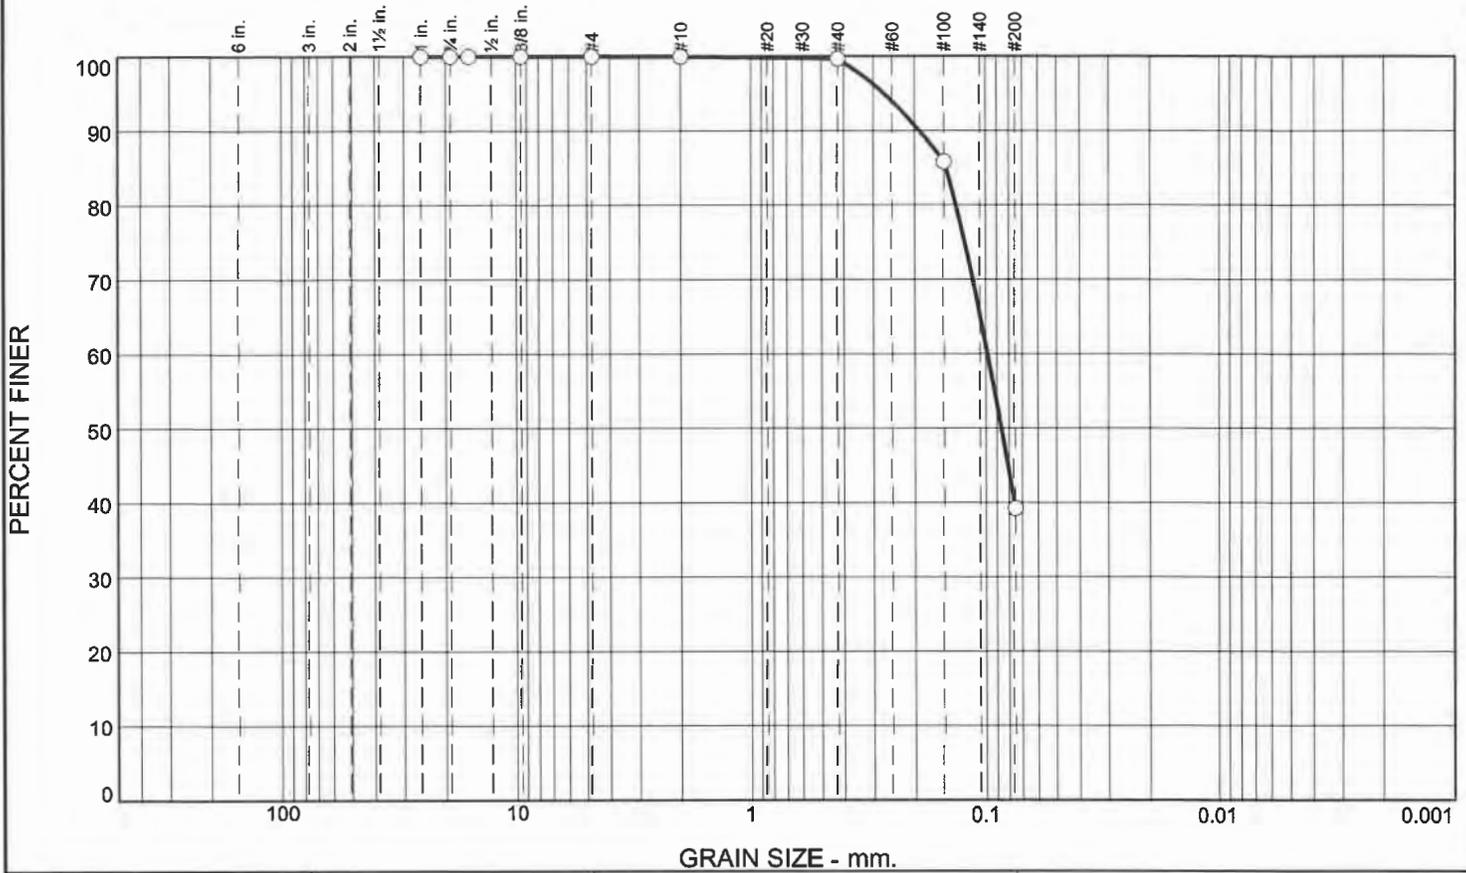
Particle Size Distribution Report

% +3"	% Gravel		% Sand			% Fines	
	Coarse	Fine	Coarse	Medium	Fine	Silt	Clay
0.0	0.0	0.0	0.0	0.3	60.5	39.2

SIEVE SIZE	PERCENT FINER	SPEC.* PERCENT	PASS? (X=NO)
1"	100.0		
3/4"	100.0		
5/8"	100.0		
3/8"	100.0		
#4	100.0		
#10	100.0		
#40	99.7		
#100	85.9		
#200	39.2
