# GEOTECHNICAL ENGINEERING REPORT

Johnson Residential Development

Poulsbo, Washington

Project No. AS240561-02 • February 13, 2025 FINAL

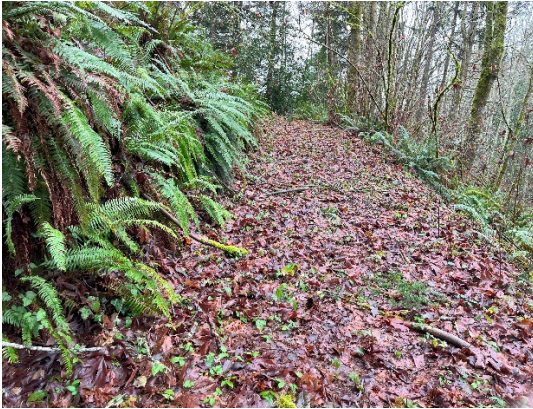
**Photograph 1.** Unpaved trail at the Site, view to the east.

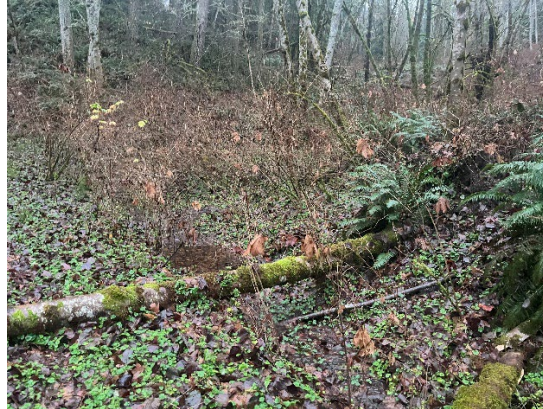
We observed areas of standing water in the ravine drainage along the west side of the Site, and areas of very saturated soils along the southern property boundary (Photograph 2). We noted several 6-inch-diameter, smooth-walled plastic pipes running underneath portions of the trail system that moved water downslope. Surface drainage conditions, as well as groundwater conditions at the Site, will vary with fluctuations in precipitation, Site usage (such as irrigation), and off-Site land use.

**Photograph 2.** Area of standing water in the southwest portion of the Site, north of State Highway 305, view to the north.

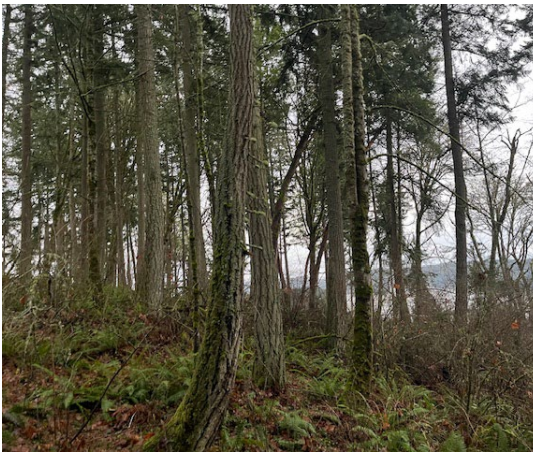
The Site is generally vegetated with mature evergreens up to 40 inches diameter at breast height, young to mature alder, fern, and woody underbrush. Limited numbers of evergreens located on the slopes had slight trunk curvature, indicating some soil movement over time (Photograph 3). The central and southern portion of the Site and within the ravine drainage along the west side of the Site is vegetated with young to mature alder, dense understory of blackberry, and woody underbrush (Photograph 4). We observed horsetail in the south portion of the Site, indicating the presence of saturated soils. Within the ravine drainage in the northwest portion of the Site we observed tilted and downed alders.

**Photograph 3.** Vegetation at the Site, view to the south.

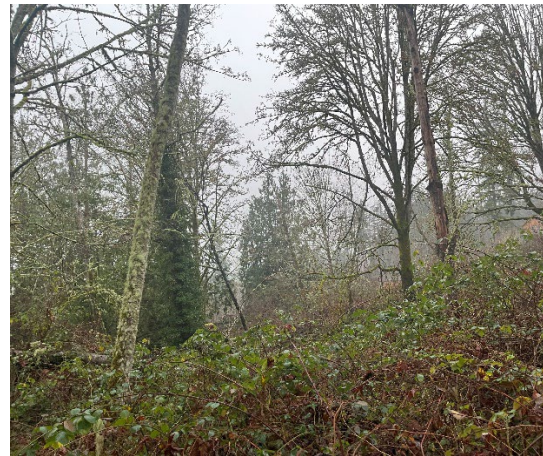
**Photograph 4.** Vegetation in the southern portion of the Site, view to the north.

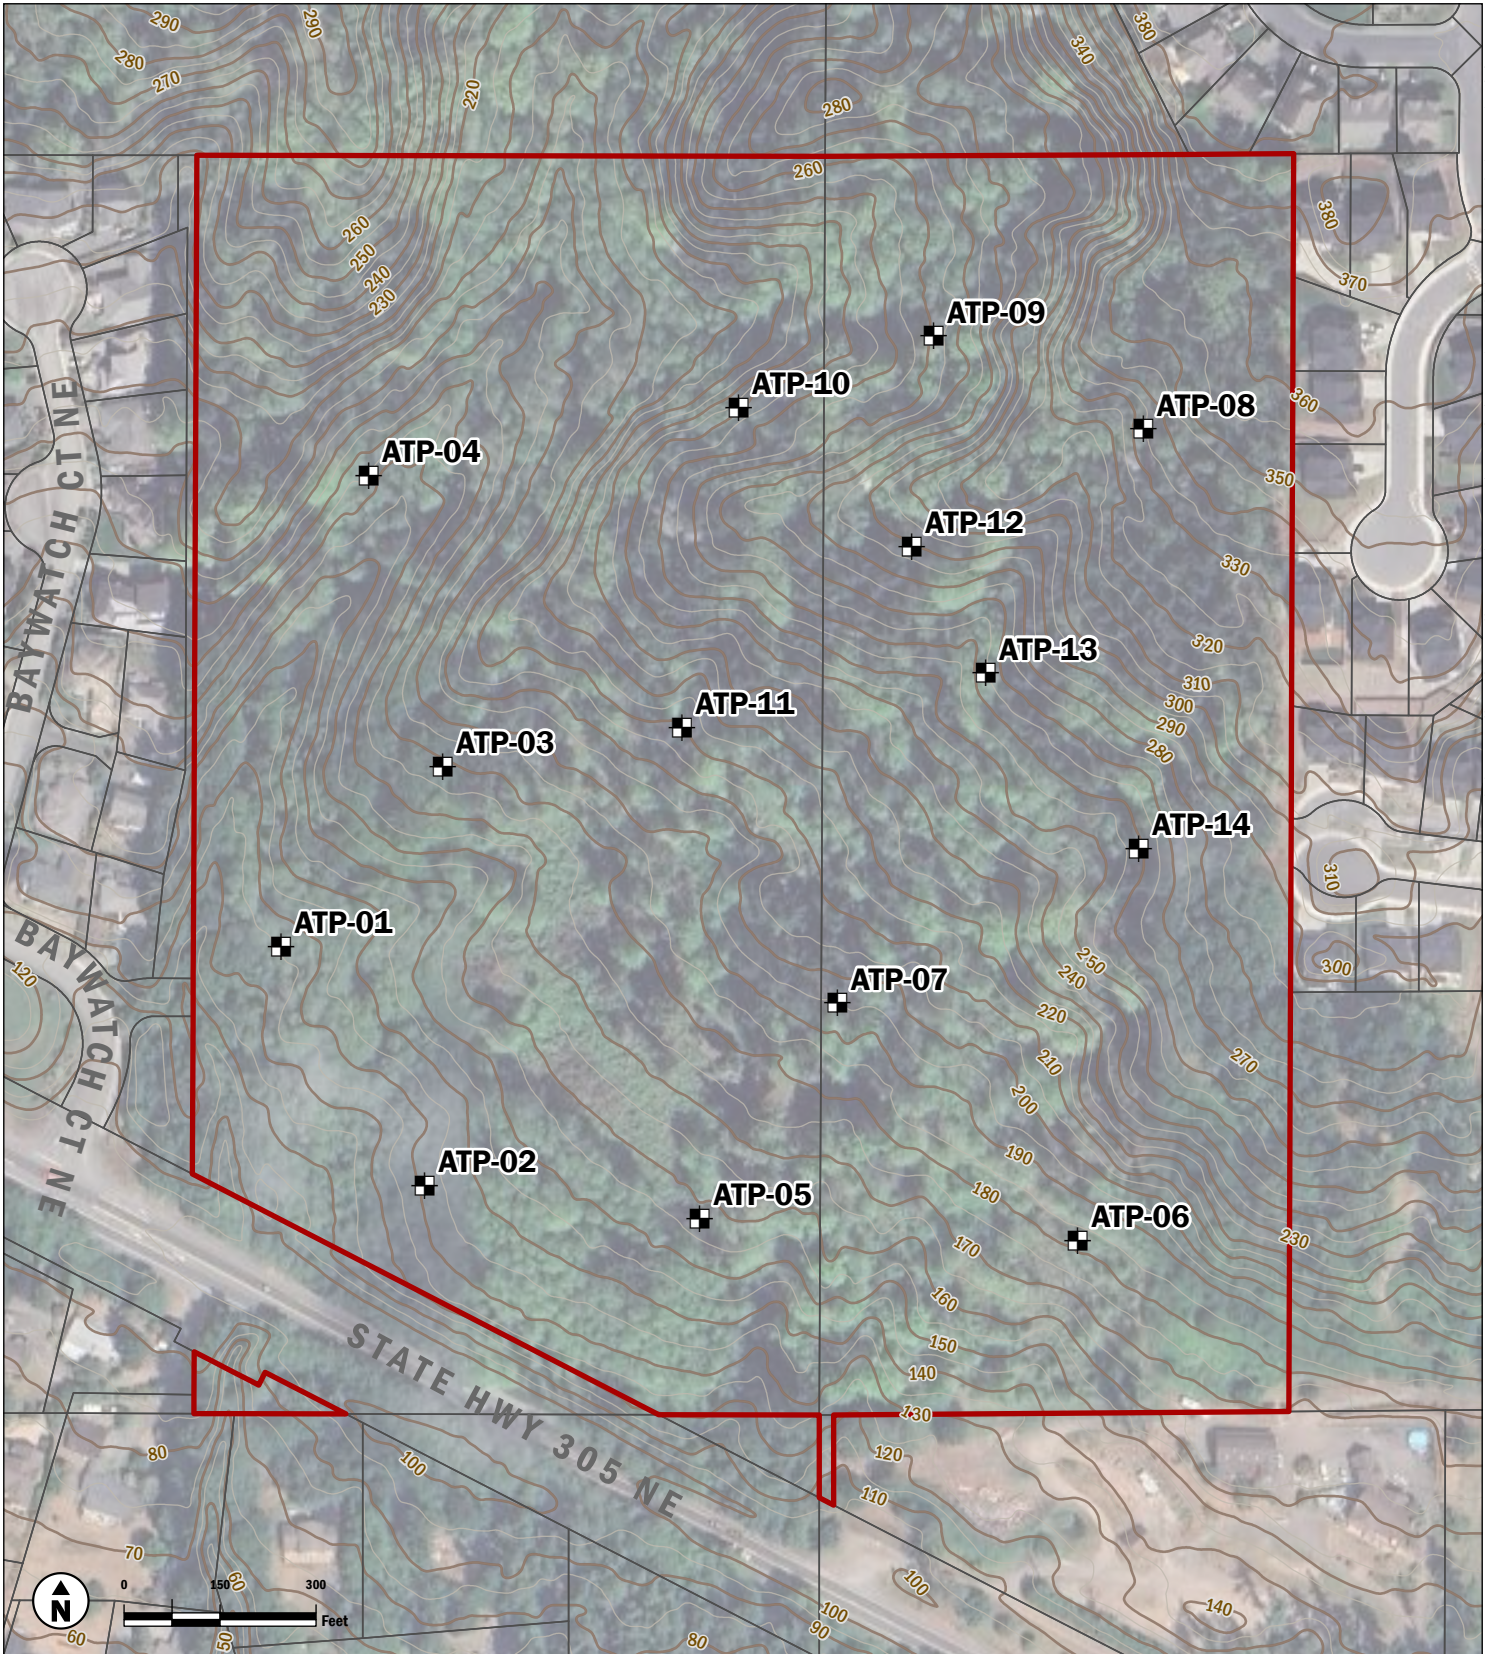
OS Plan: C:\projects\JohnsonProperty\_240561\JohnsonProperty\_240561.mxd, 02 - Site Exploration Plan | User: haley.dunham | Print Date: 2/14/2025

On January 2 and 3, 2025, Aspect oversaw the advancement of 14 test pits, designated ATP-01 through ATP-14, terminated between 10 and 13 feet below ground surface (bgs). Detailed descriptions of the subsurface conditions and soil characteristics are provided in the exploration logs in Appendix A. The locations of the test pits are shown on Figure 2.
