## **Wetland Review**

# BGE Environmental, LLC.

RE: Wetland Review Dauntless Dr NW, Poulsbo Tax Parcel 102601-1-044-2009

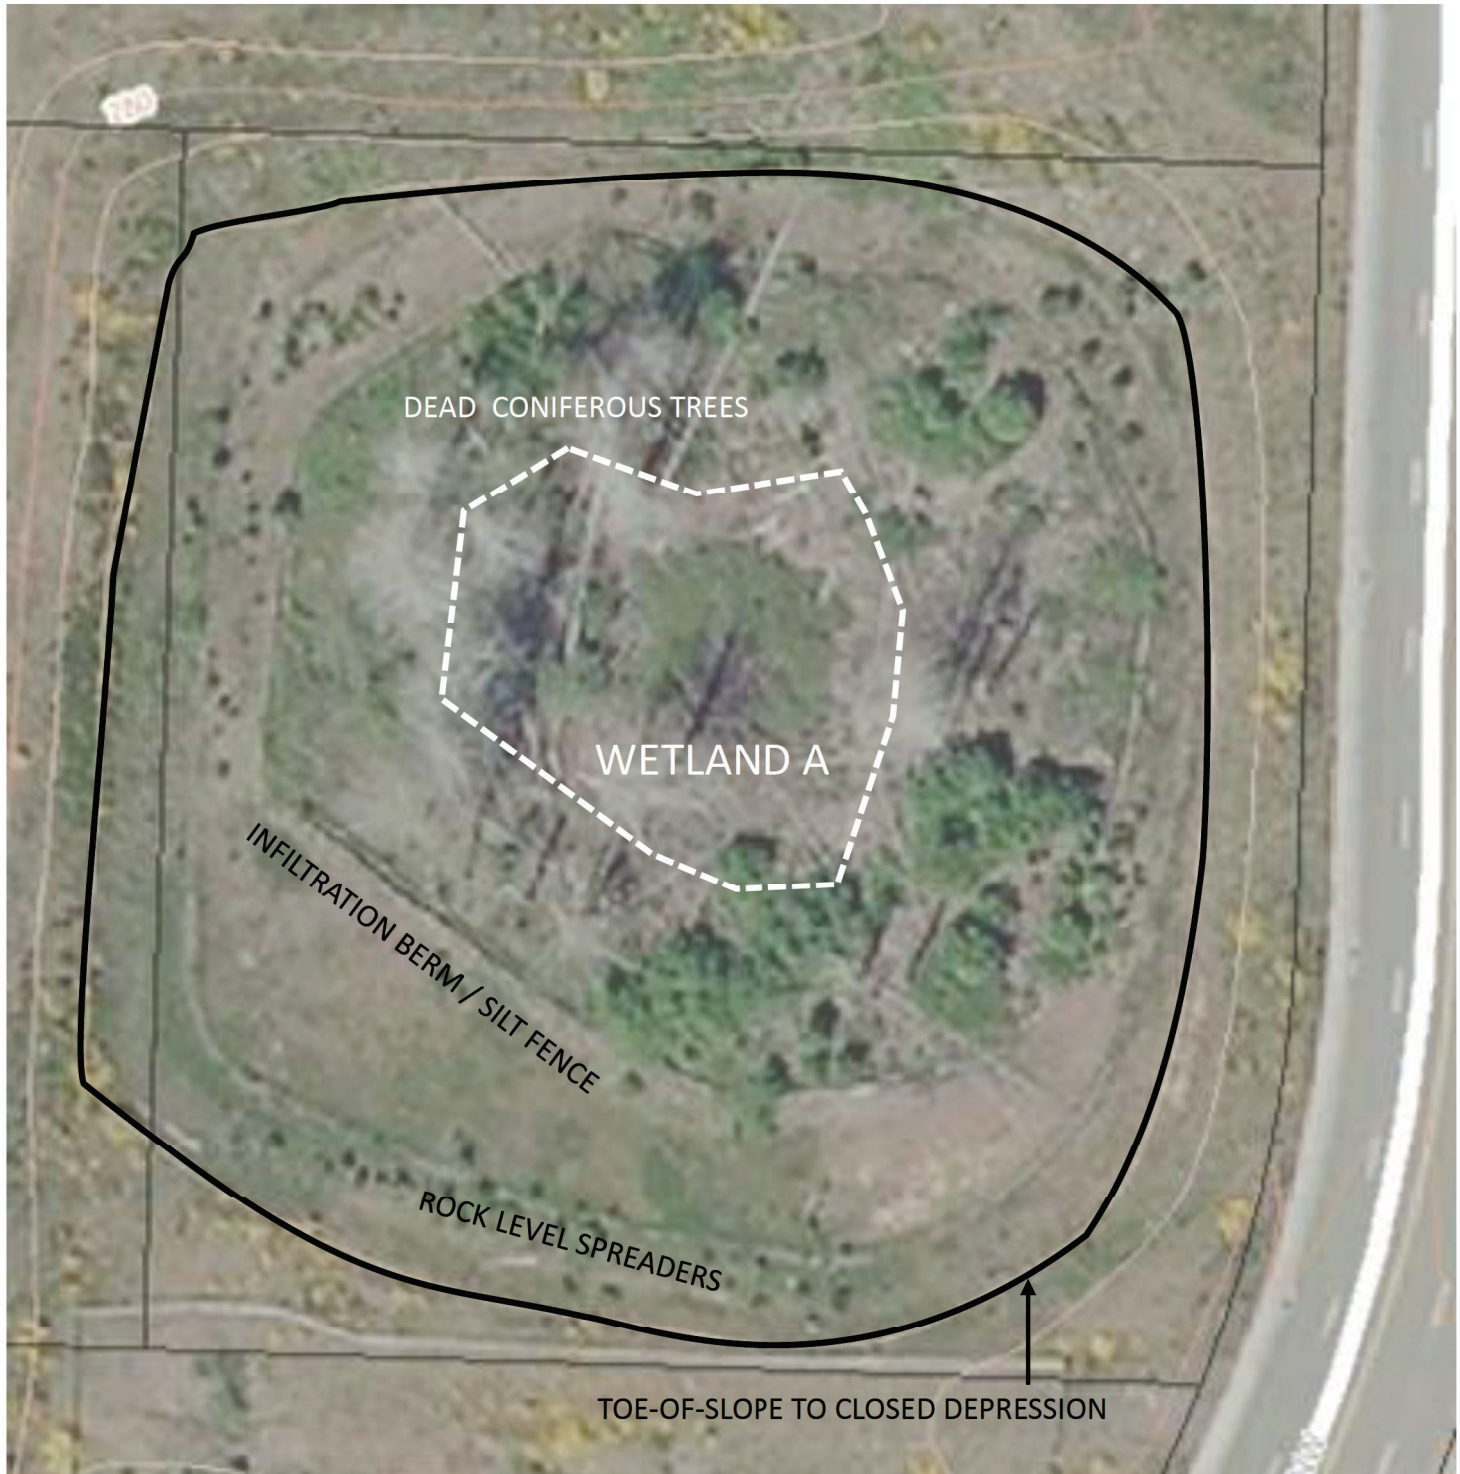
EXHIBIT C: OBSERVED CONDITIONS OF CLOSED DEPRESSION

By 2009 the closed depression was established around Wetland A. The infiltration berm was constructed and the level spreaders in place, see Exhibit C. The conifer trees are dead, and

deciduous vegetation is establishing in the buffer and closed depression. A wet weather aerial from 2012 shows that the entire closed depression is inundated in the wet season, see Exhibit D. Only a small upland island is noted on the infiltration berm along the southern side. Google Earth aerials suggest that the conifers were needle bare by 2006. Inundation to the toe-of-slope of the closed depression is observable in other years on both Kitsap County GIS and Google Earth. The closed depression, which includes Wetland A and its buffer, is observed as inundated all years, personal communication Jim Laughlin, owner. Today the closed depression is a closed canopy of deciduous trees. The wetland buffer is also a closed canopy of deciduous trees, and the wetland is seasonally inundated with a smaller percentage of scrub shrub habitat along the it's outer edge or ecotone.
