Pinnacle at Liberty Bay

Preliminary Stormwater Site Plan Report

June 20, 2025

Revised: April 6, 2026

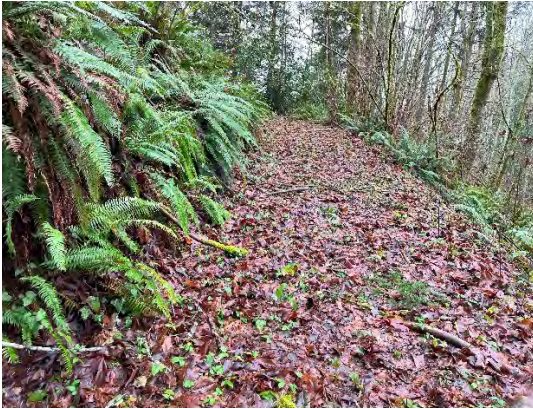
Photograph 1. Unpaved trail at the Site, view to the east.

The Site consists of three undeveloped parcels: 232601-4-001-2009, 242601-3-003-2008, and 252601-2-047-2007. The west parcel (232601-4-001-2009) is approximately 19 acres and measures 1,300 feet north to south and 660 feet east to west, with State Highway 305 crossing through the southwest corner of the parcel. The east parcel (242601-3-003-2008) is approximately 15 acres and measures approximately 1,300 feet north to south and 440 feet east to west and is north of State Highway 305. The south property (252601-2-047-2007) is about 0.03 acres and measures approximately 90 feet north to south and 15 feet east-to-west (County, 2025). The Site is accessed on the east side from Crystallia Court NE. The Site contains an unpaved trail system constructed with cut slopes and graded paths (Photograph 1).

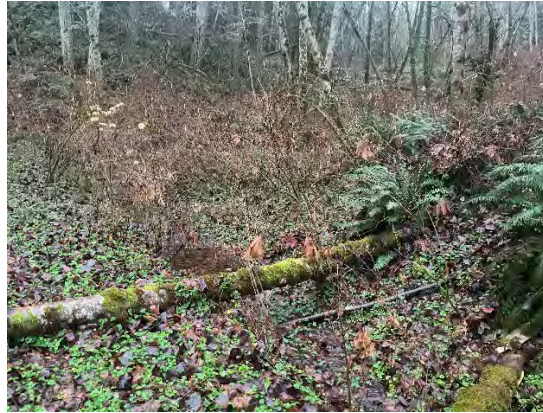
We observed areas of standing water in the ravine drainage along the west side of the Site, and areas of very saturated soils along the southern property boundary (Photograph 2). We noted several 6-inch-diameter, smooth-walled plastic pipes running underneath portions of the trail system that moved water downslope. Surface drainage conditions, as well as groundwater conditions at the Site, will vary with fluctuations in precipitation, Site usage (such as irrigation), and off-Site land use.

Photograph 2. Area of standing water in the southwest portion of the Site, north of State Highway 305, view to the north.

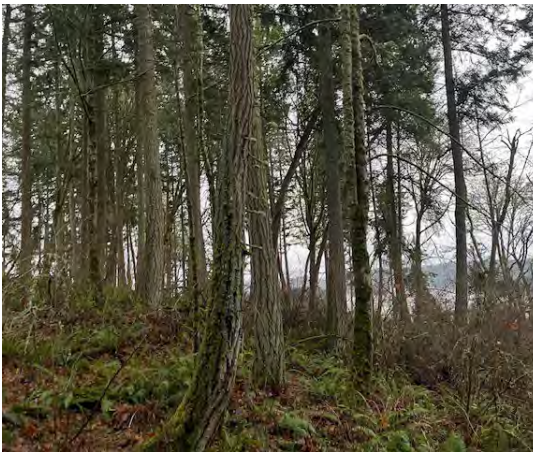
Photograph 3. Vegetation at the Site, view to the south.

The Site is generally vegetated with mature evergreens up to 40 inches diameter at breast height, young to mature alder, fern, and woody underbrush. Limited numbers of evergreens located on the slopes had slight trunk curvature, indicating some soil movement over time (Photograph 3). The central and southern portion of the Site and within the ravine drainage along the west side of the Site is vegetated with young to mature alder, dense understory of blackberry, and woody underbrush (Photograph 4). We observed horsetail in the south portion of the Site, indicating the presence of saturated soils. Within the ravine drainage in the northwest portion of the Site we observed tilted and downed alders.

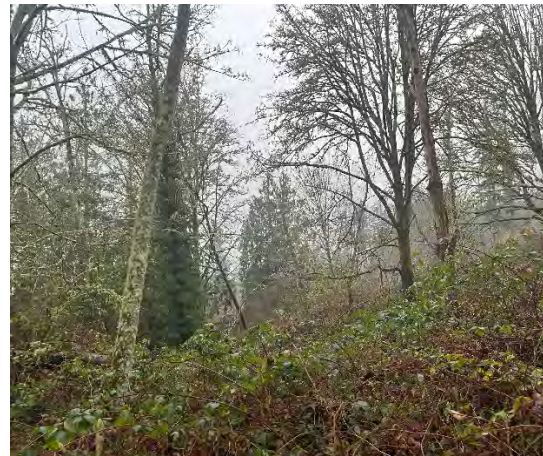
Photograph 4. Vegetation in the southern portion of the Site, view to the north.

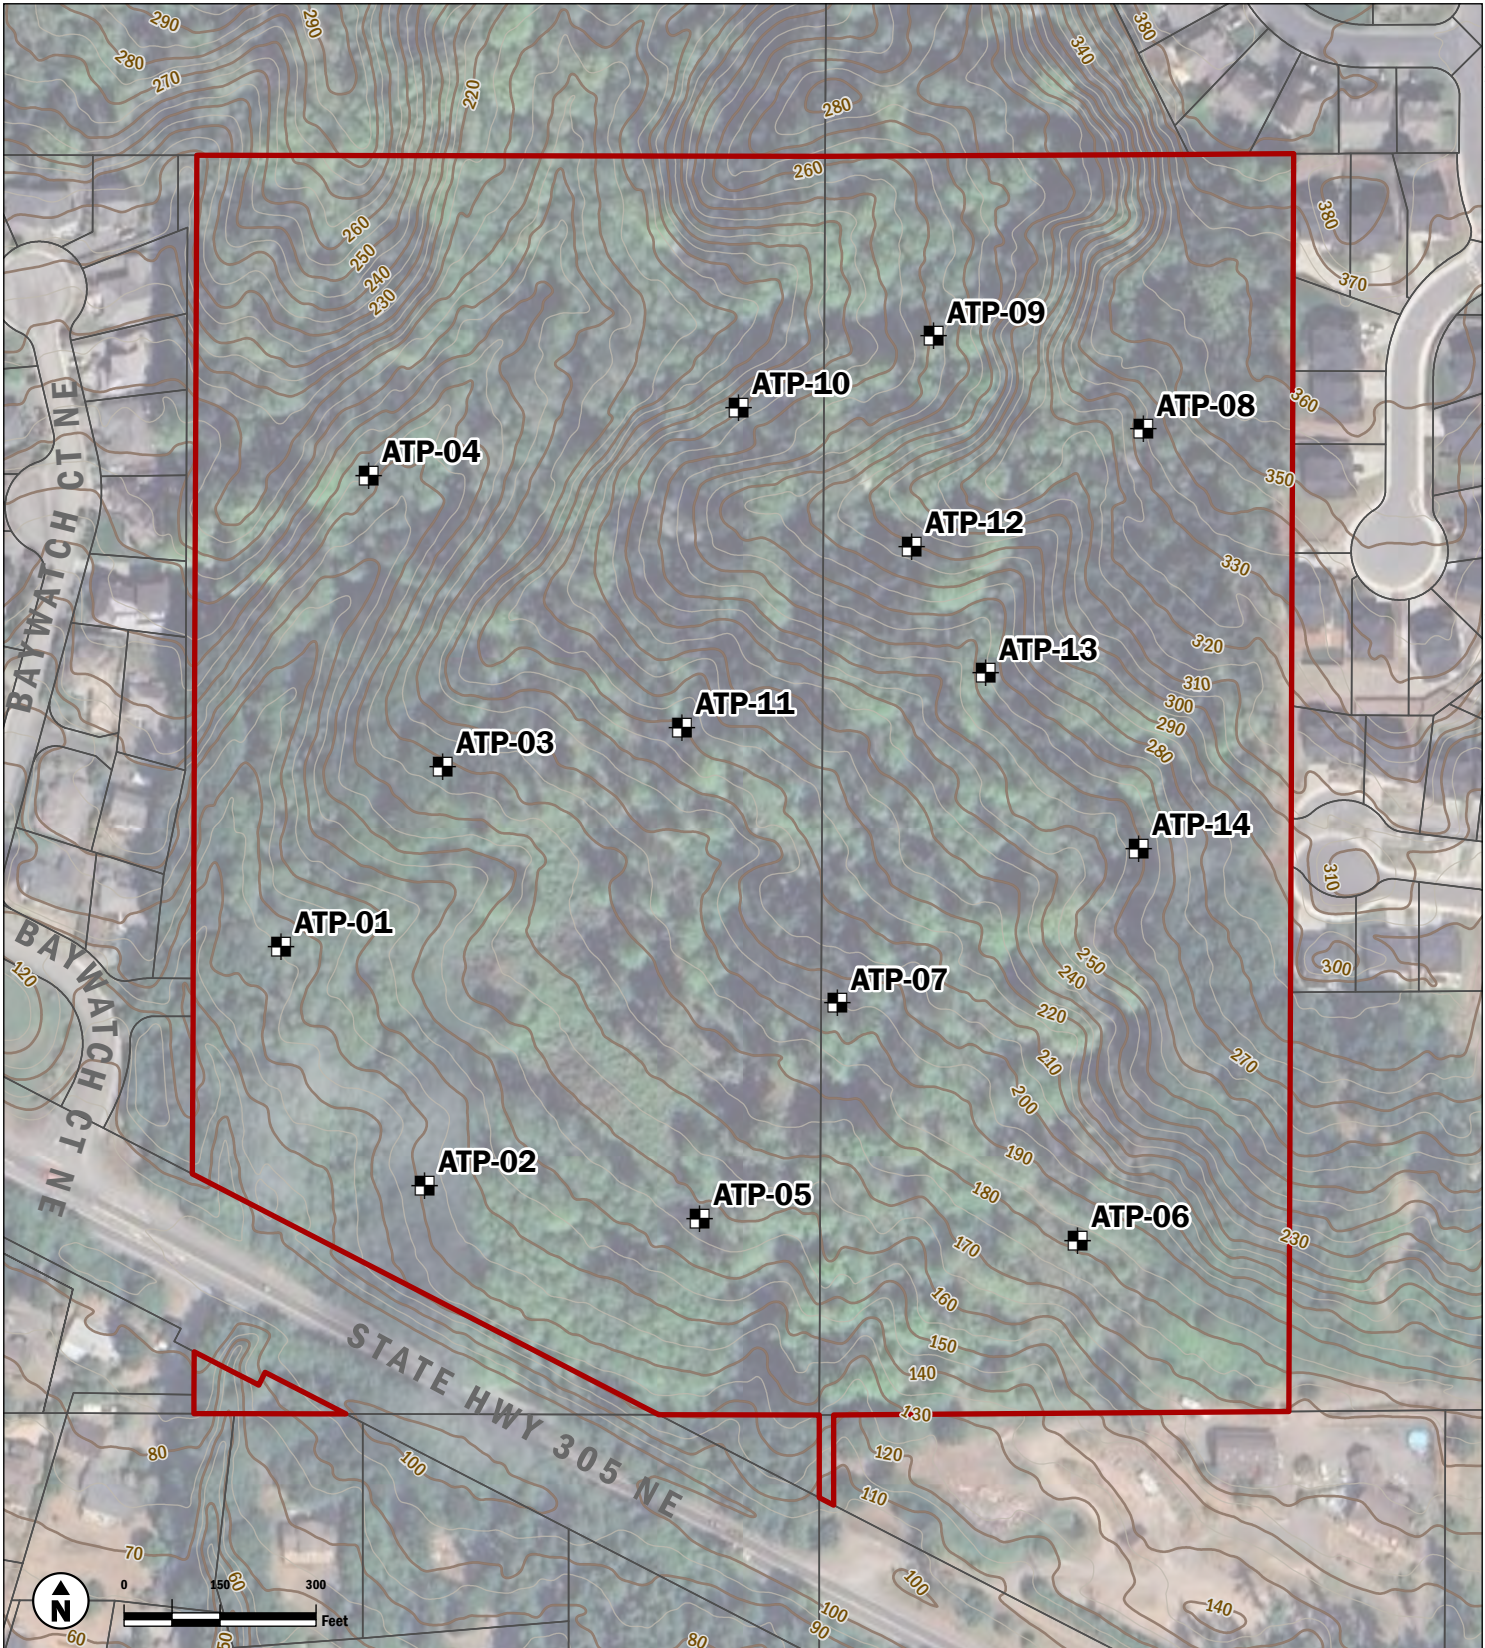
FEB-2025	BY: AJD / HMD	FIGURE NO. 3
	PROJECT NO. AS240561-02	REVISED BY: --- / ---

On the remainder of the Site, we encountered pre-Vashon glaciolacustrine deposits with varying degrees of weathering. A geologic map presenting inferred geologic contacts based on our subsurface investigation is presented as Figure 3. A summary table of the units encountered at the respective depths is presented in Table 1 following the descriptions.

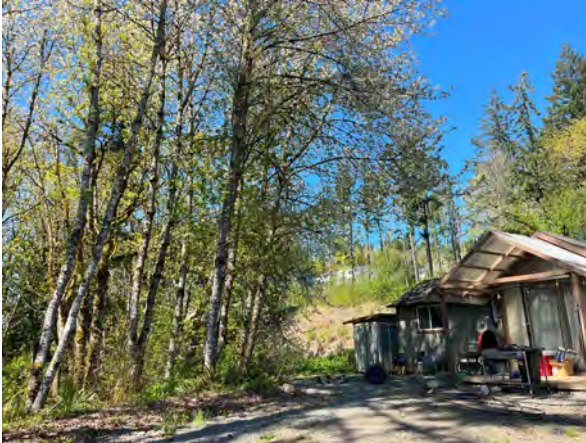
Photograph 1. Existing Residence on central parcel, view to the northwest, on April 17, 2025.

The central parcel is developed with a one-story, 577-square-foot residence built in 1935 with a gravel access driveway from the south, near the central area of the parcel (Photograph 1). A stormwater pond is located in the southeast corner of the central parcel (Photograph 2).

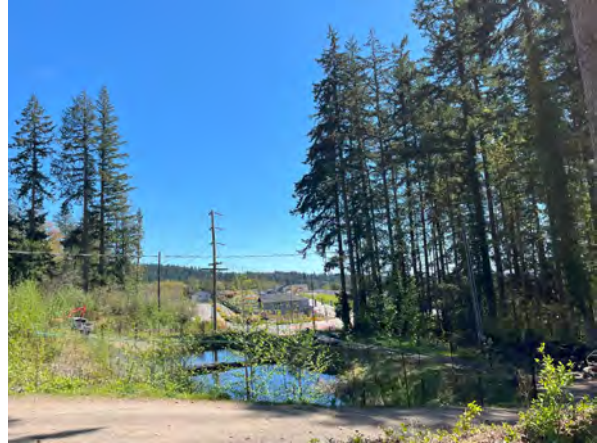
Water was observed in the stormwater pond. Outside the pond, no water seepage, springs, flowing water, evidence of past standing or flowing water, hydrophilic vegetation, or saturated soils were observed.

Photograph 2. Stormwater pond in southeast corner of central parcel, view to the east, on April 17, 2025.
